GEF 1, 2, and 3 Office Building Repairs and Renovation Study

DOA # 20H2B / HGA #1190-033-01

UPDATED FINAL REPORT

JULY 27, 2022

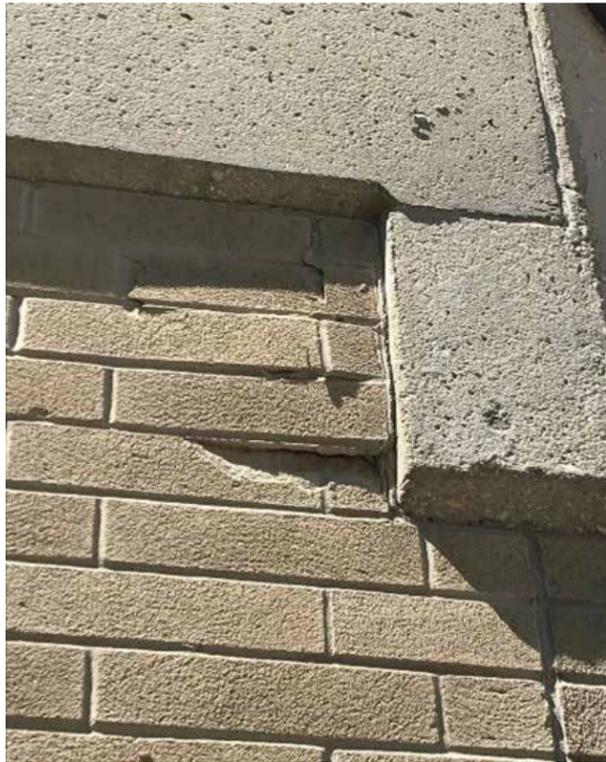
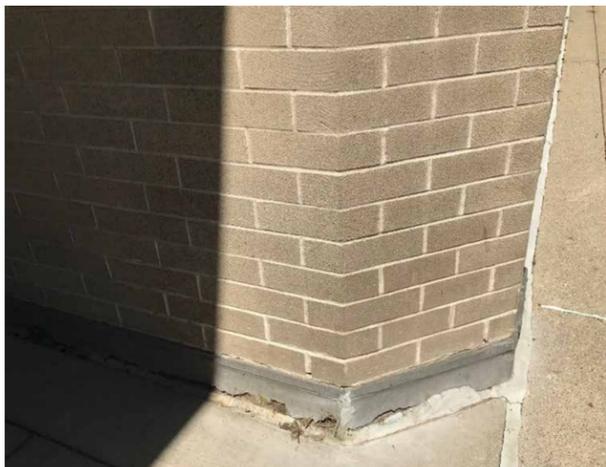
Brick façade – Overall the brick exterior façade is in good condition, however, there are areas of mortar deterioration along with minimal areas where there are brick faces with surface pops and spalling. The flashing system at the base of the building is showing signs of major deterioration and failure and should be replaced. The recommendation is to complete a tuckpointing project to repair the damaged areas and replace base flashing.

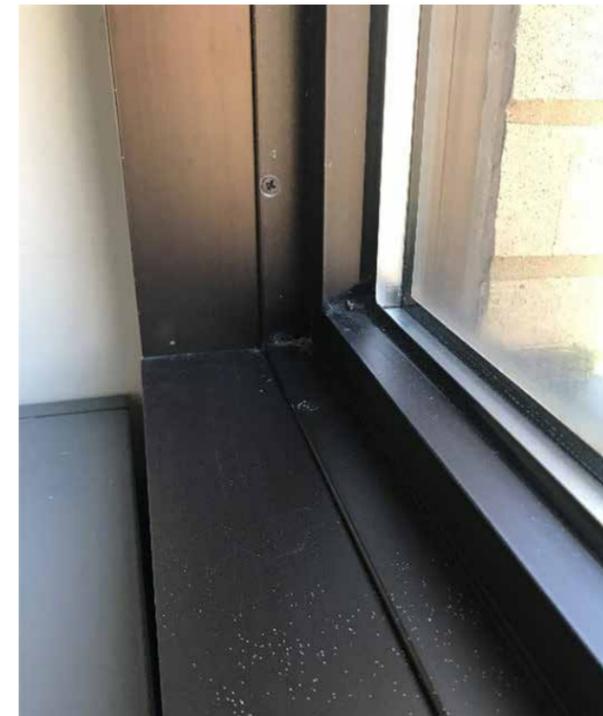
Exterior Window Systems – the windows feature an aluminum framing system with insulated glass. The windows are original (installed in 1978) and are past their life expectancy. The new glass coating and insulated glass systems would improve the building performance. Recommendation is to remove and replace the exterior window systems.

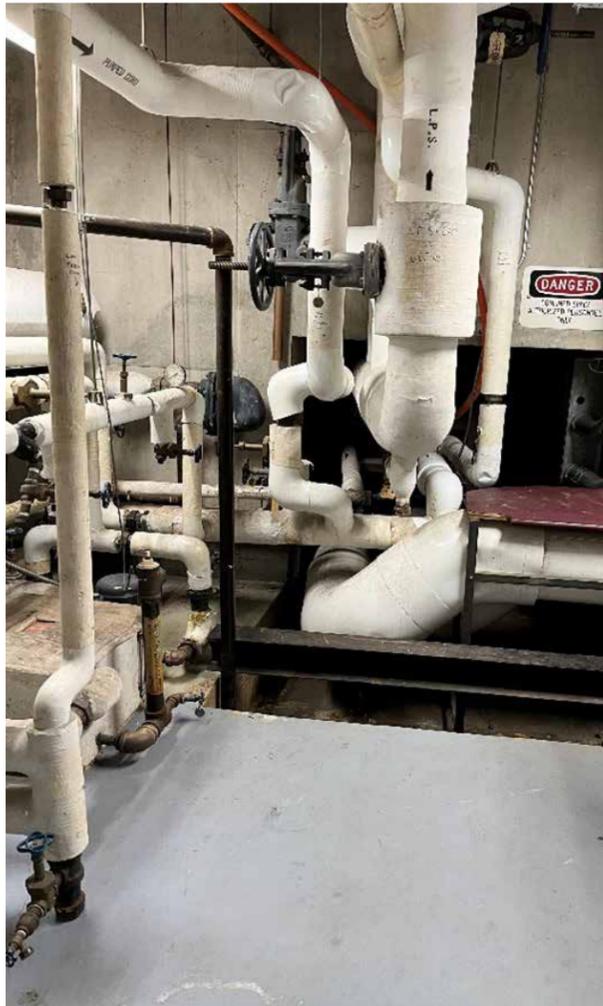
Piping Distribution Insulation – Nearly all of the insulation on HVAC piping throughout the building is original to when building was first constructed and has deteriorated in many locations requiring replacement. This includes chilled water, hot water, steam, steam condensate return and cooling coil condensate drain piping. Recommendation is to replace all insulation on all these piping systems.

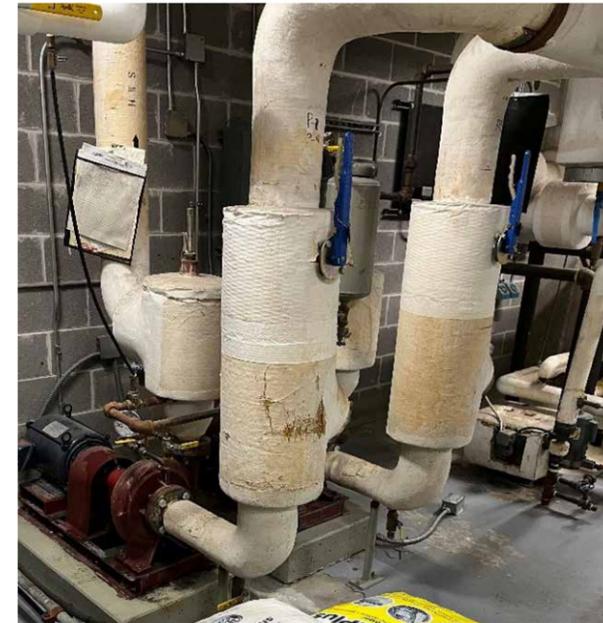
Hot Water Heating Distribution Pumps – All hot water heating distribution pumps will eventually be in need of replacement. Some are in immediate need of replacement now. Recommendation is to replace all pumps as needed over time

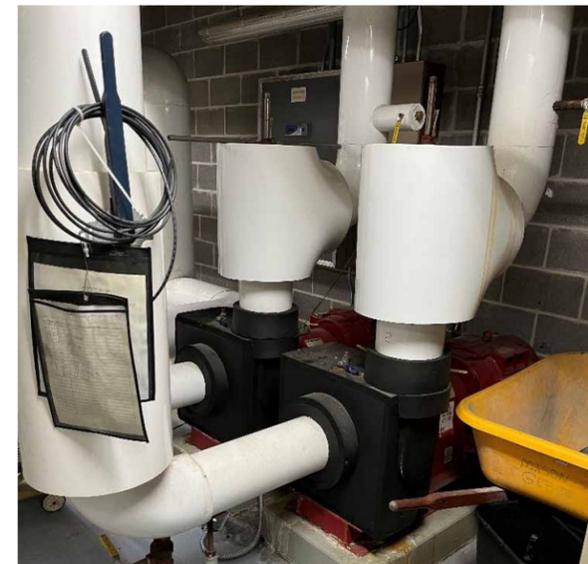
Chilled Water Distribution Pumps – All chilled water distribution pumps will eventually be in need of replacement. Some are in immediate need of replacement now. Recommendation is to replace all pumps as needed over time.

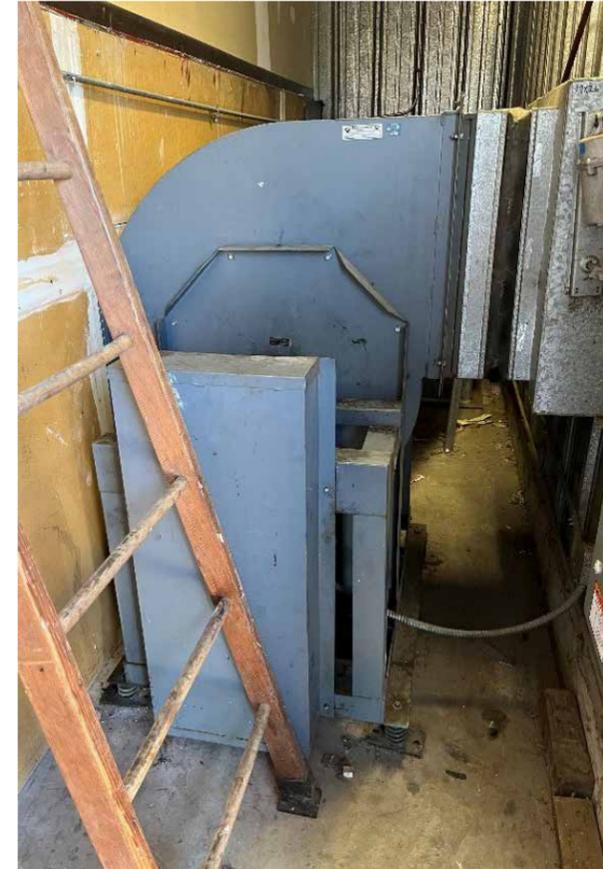
Building Exhaust Fans – Nearly all building exhaust fans are original to the building when the building was first constructed. These fans are inefficient and have exceeded their life expectancy. Recommendation is to replace all exhaust fans.

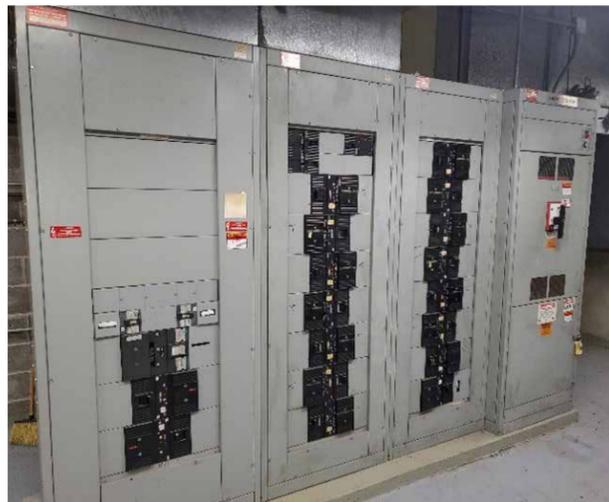
Electrical Services - The building is currently served with secondary electrical service from Madison Gas & Electric Company. Utility transformers are located in the transformer vault in this building. Service One is a 2000 amp switch with 2000 amp fuses, 480Y/277 volt, GE fused switchgear. This switchgear is indicated as GEF2 SWGR-MN. Service Tap ahead of the main switch for Service One is a 200 amp switch with 200 amp fuses, 480Y/277 volt, GE. This switch is indicated as B-DISC FIRE PUMP, 50HP. MG&E Peak load reading for this building is 425KW, 512 amps. Switchboards were all installed around 1978 are all reaching end of useful life. Degradation of some of the equipment due to moisture was observed. Code required clearances are also an issue.

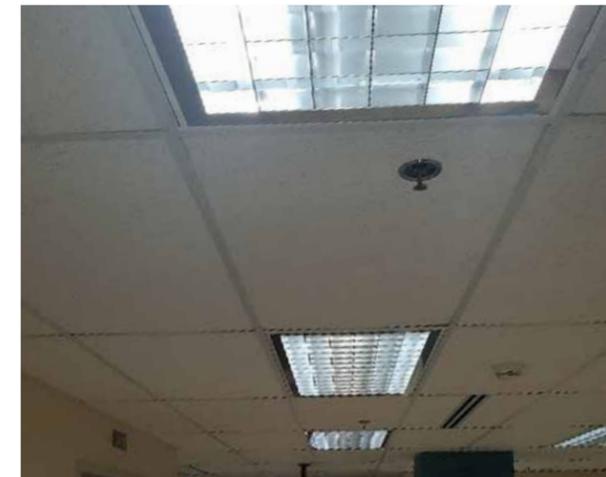
Lighting Controls - Existing light fixtures generally were fluorescent and converted to LED with the removal of the existing lamps and ballasts and replaced with LED type lamps, which have integral driver. LED appears to have been installed during the building shut down in 2021. Exit lights appear to have been retrofitted to LED technology. Lighting controls in general appear to be manual type controls with very few automatic lighting controls observed.

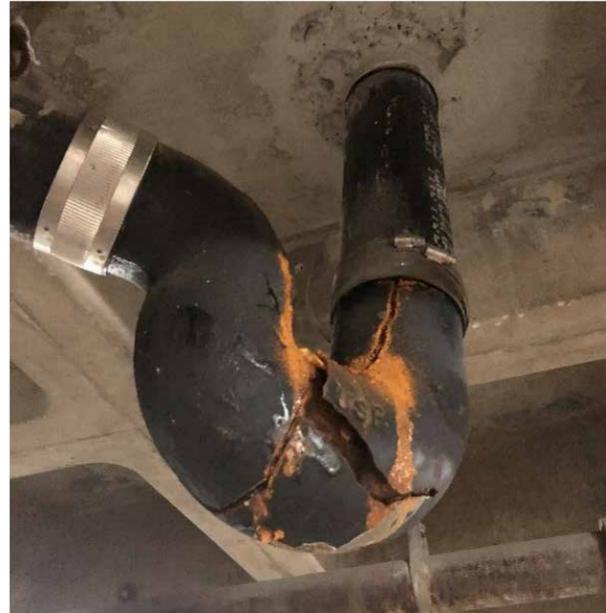
Sanitary Waste and Storm Piping - The sanitary waste/vent and storm piping within the building mostly consists of hub and spigot cast iron. In some areas, the cast iron piping is cracking, crumbling, and failing. In particular, the entire storm piping system and drains within the parking structure are failing. It does not function as it should because most or all the drains have clogged, and the piping is beyond repair. Underground piping was not inspected, but based on its age, it is likely to be in less than ideal condition.

During a major renovation, the entire sanitary waste/vent and storm water system should be removed and replaced with new piping. This includes the underground piping. It may be functioning at this point, but it is past its expected life cycle.

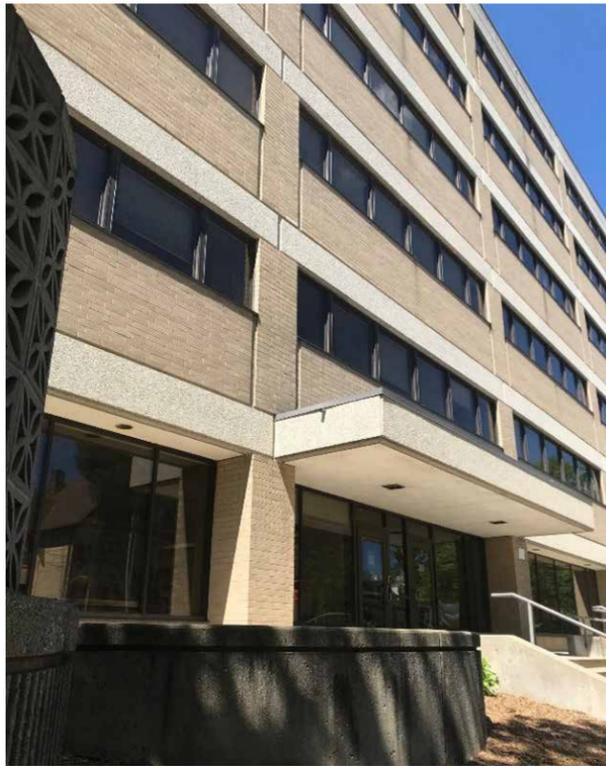
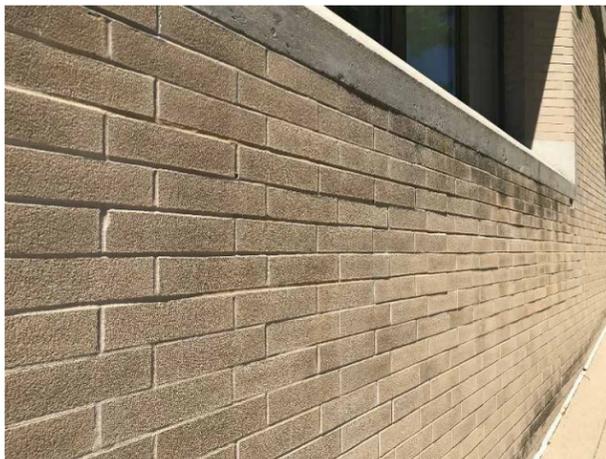
Brick façade – Overall the brick exterior façade is in fair condition, however, there are areas of mortar deterioration along with minimal areas where there are brick faces with surface pops and spalling. The flashing system at the base of the building is showing signs of major deterioration and failure and should be replaced. The recommendation is to complete a tuck pointing project to repair the damaged areas and replace base flashing.

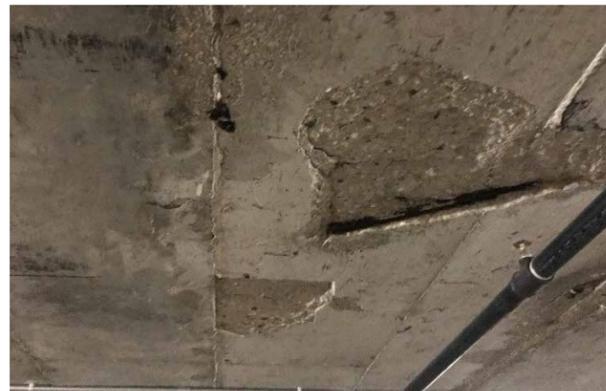
Parking Structure Concrete Frame – The cast concrete flat slab structural system appears to be sound and in over-all fair condition, however there are some limited areas where surface concrete has popped. HGA, as part of an additional study, will have a structural engineer evaluate the concrete structure in the parking structure and make additional recommendations on the direction of repairs, cost and timing. This additional structural study will be completed by end of July 2022. Recommendation is for the areas of spalled concrete to be cleaned and repaired. Current condition has approximately 10 – 15 locations for waffle slab repair.

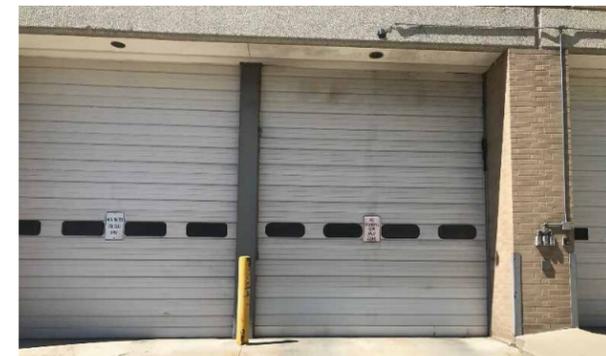
Exterior Doors / Overhead Doors – there is currently a blend of painted hollow metal doors at service entries, in the parking structure levels and some stair egress locations and then aluminum storefront at major entries to the building. The hollow metal doors and frames are in poor condition showing major rust and deterioration. The aluminum storefront entry systems are in fair condition. Recommendation is to replace all hollow metal doors and frames. Aluminum frames should be reviewed for sealant replacements and general maintenance. The overhead doors should be replaced along with the operators and control systems

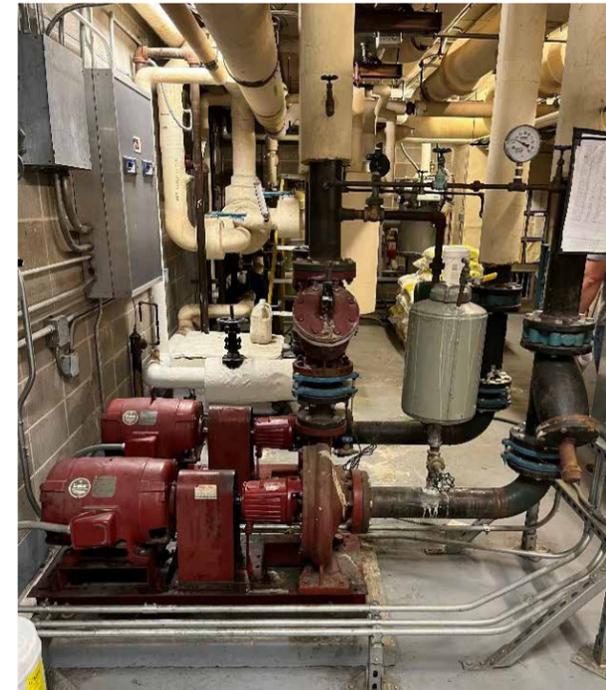
Hot Water Heating Distribution Pumps – All hot water heating distribution pumps will eventually be in need of replacement. Some are in immediate need of replacement now. Recommendation is to replace all pumps as needed over time.

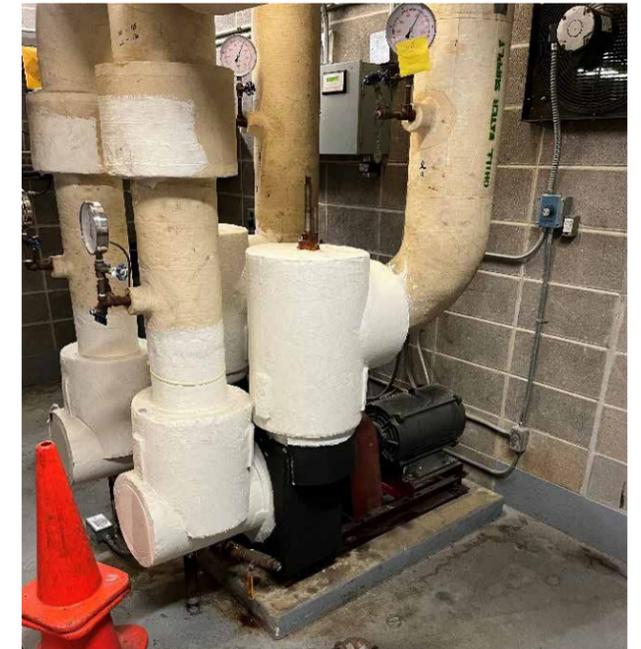
Chilled Water Distribution Pumps – All chilled water distribution pumps will eventually be in need of replacement. Some are in immediate need of replacement now. Recommendation is to replace all pumps as needed over time.

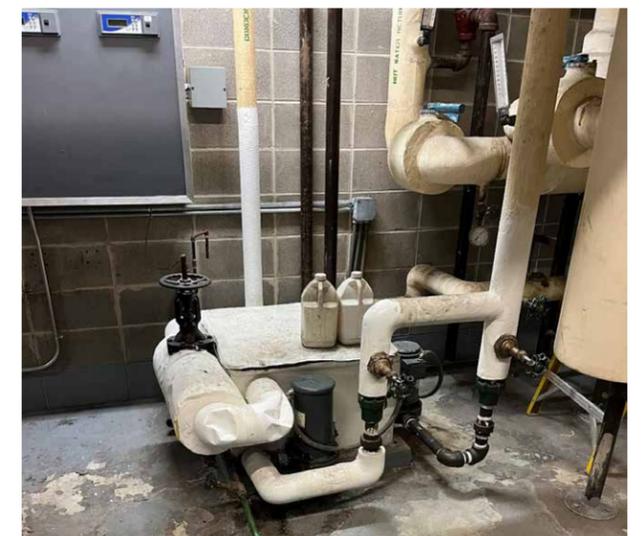
Steam Condensate Return Pumps – All steam condensate return pumps will eventually be in need of replacement. Some are in immediate need of replacement now. Recommendation is to replace all pumps as needed over time.

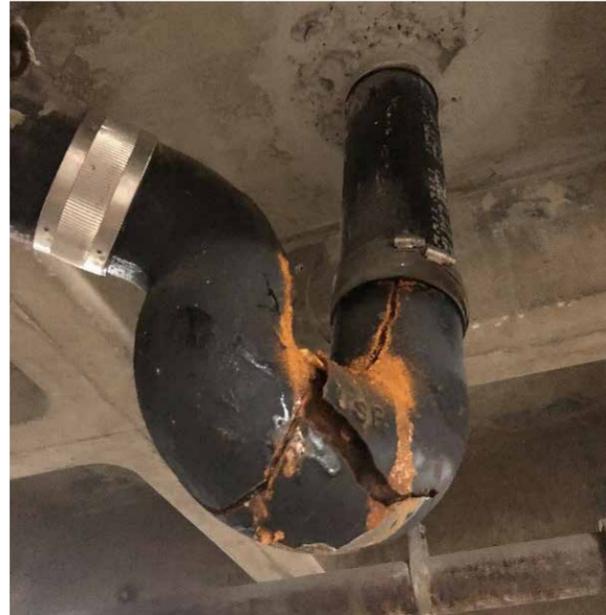
Sanitary Waste and Storm Piping - The sanitary waste/vent and storm piping within the building mostly consists of hub and spigot cast iron. In some areas, the cast iron piping is cracking, crumbling, and failing. In particular, the entire storm piping system and drains within the parking structure are failing. It does not function as it should because most or all the drains have clogged, and the piping is beyond repair. Underground piping was not inspected, but based on its age, it is likely to be in less than ideal condition.

During a major renovation, the entire sanitary waste/vent and storm water system should be removed and replaced with new piping. This includes the underground piping. It may be functioning at this point, but it is past its expected life cycle.
