DOA # 21I2J / HGA #1190-035-00

1 WEST WILSON STREET BUILDING ASSESSMENT AND RECOMMENDATIONS STUDY

FINAL REPORT - MAY 10, 2022

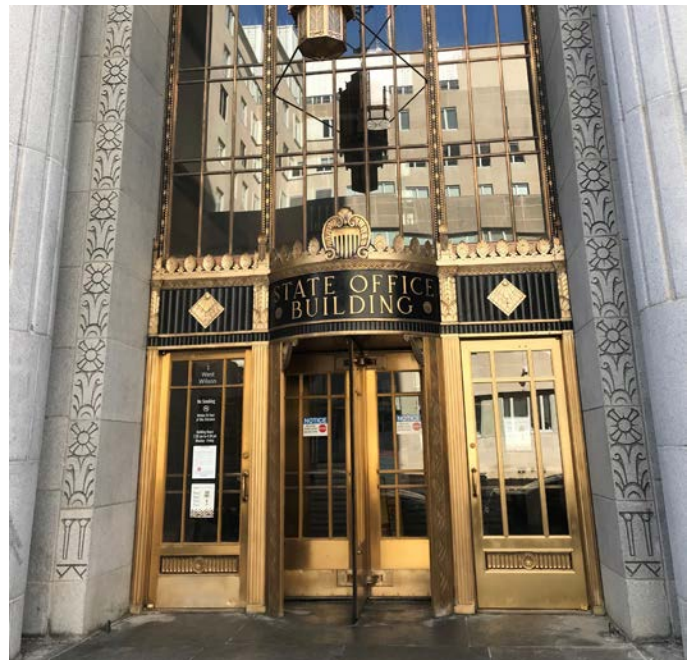
- The existing bronze revolving door no longer functions and will need to be replaced with a new bronze swing door.

Existing bronze revolving door will need to be replaced

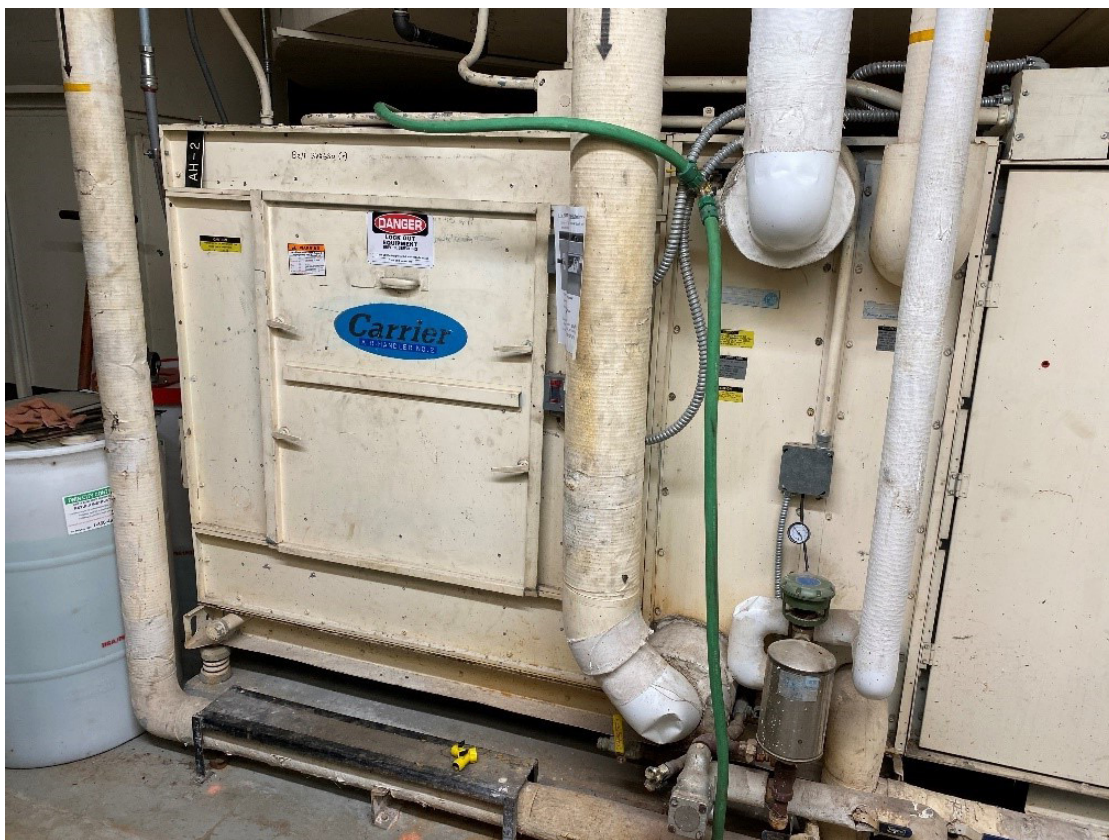
The building heat is provided by a low pressure steam system. Much of this system is original to the building and is in constant need of repair; this steam system is proposed to be replaced with a new hydronic heating system. The ventilation system in the building consists of 23 different air handling units of varying sizes spread throughout many of the floors. Some of the units are more than 50 years old and do not meet current ventilation code requirements. The recommendation is for all new air handling units, however two options or approaches for the replacements are proposed. The building is cooled by a chilled water system. The existing chilled water pumps and chilled water piping are in fair to good condition and only reconfiguration of the piping to new equipment locations will be required as part of the renovation. Lastly, the controls on the systems are a blend of pneumatic, electric and DDC; all controls should be removed and replaced with a new DDC Control System.

Example of old AHU with no access between heating and cooling coils or humidifier

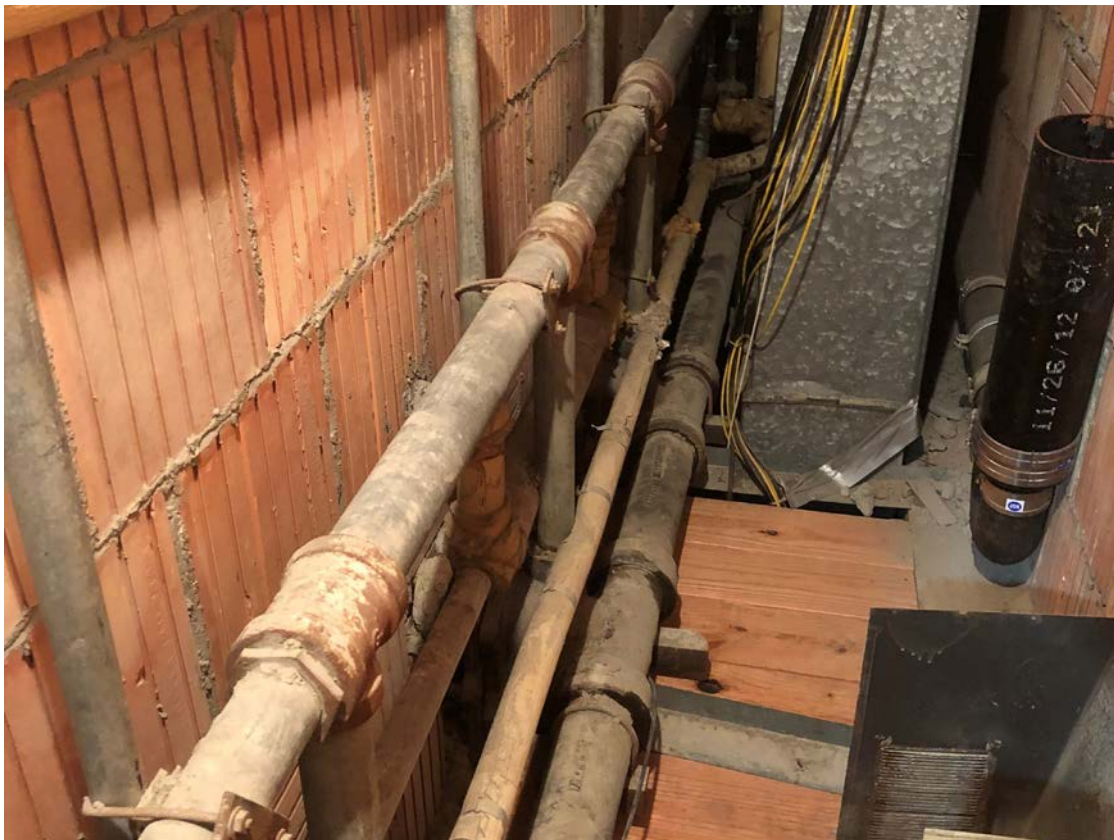
With some small exceptions, the plumbing equipment and piping infrastructure has exceeded their life expectancy. Some of the plumbing equipment requires frequent maintenance and repair to keep it operational. The sanitary waste/vent, storm water, and domestic water piping infrastructure is completely deteriorating with cracking, corroding, and leaking in many locations. Some valves are inoperable, and rust is prevalent in the building water supply. A large majority of the plumbing systems in the building require full demolition, removal, and replacement with new products.

Plumbing piping in chase behind typical existing toilet room

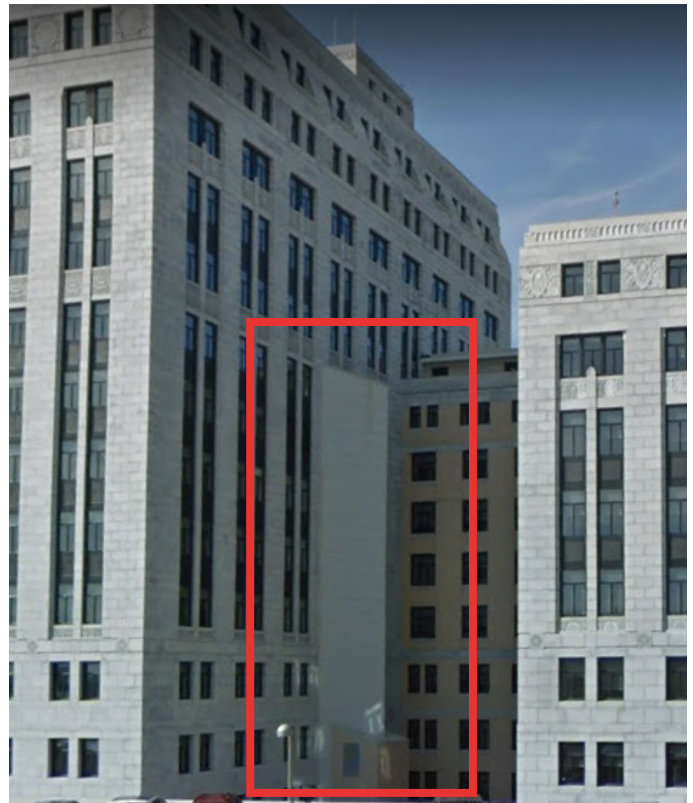
- One element on the exterior of the building that is in poor condition are the two mechanical shafts that were added to the exterior walls on the southern courtyards. These shafts are not water-tight and have been leaking with the walls and finish showing deterioration. These shafts are proposed to be resized for the new mechanical equipment and completely rebuilt.

The existing building has triangular exterior HVAC shafts that were added to the courtyards. These shafts, shown in the photo to the right, are in poor condition with serious water infiltration issues. This report is recommending that the shafts be completely rebuilt. The shafts can be triangular or rectangular. A total of four shafts are required. Each shaft will house a single 60x70 duct or a single 72 in. diameter round duct. Two shafts will be for outdoor air intake. The other two shafts will be for building relief air. The louvers for the outdoor air intake shafts should be as high as possible (minimum 20 ft. above grade) to minimize intake of any parking lot fumes.

Exterior Mechanical Shafts in southern courtyards

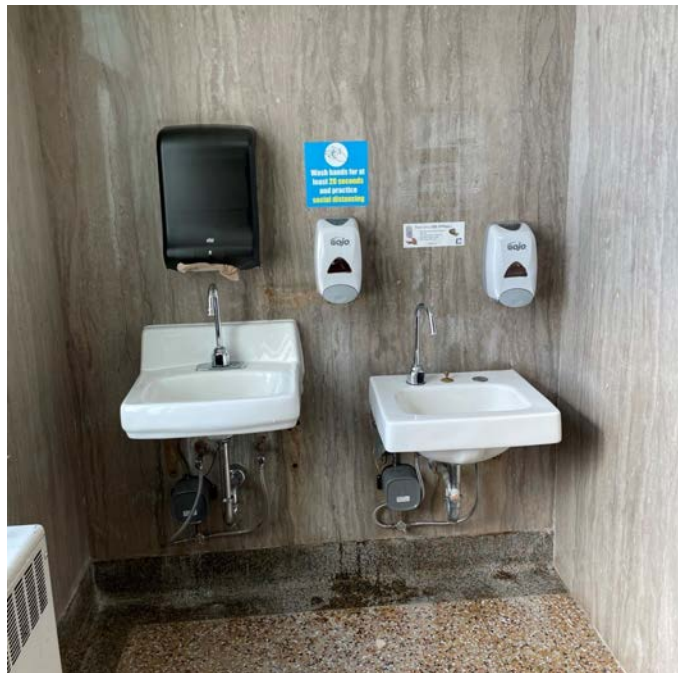
Images shows damage done over the years by water staining

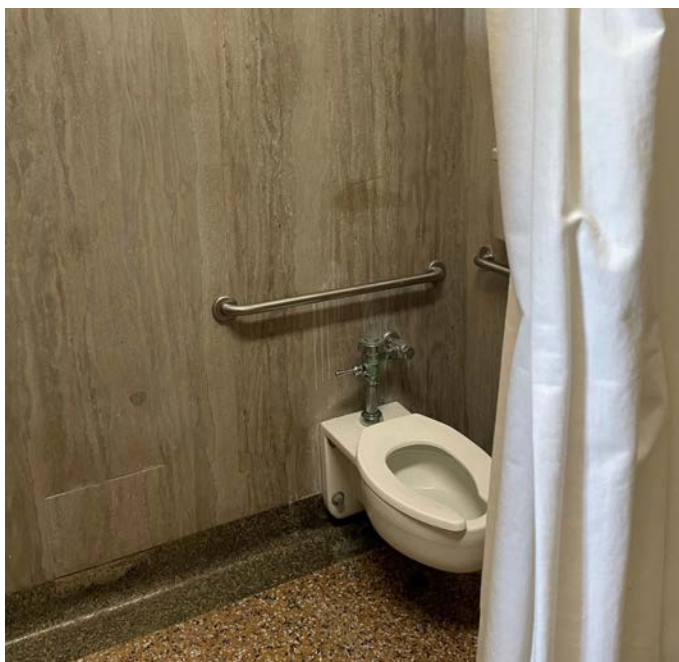
Marble walls of Toilet Room, "accessible" stall uses shower curtain as door

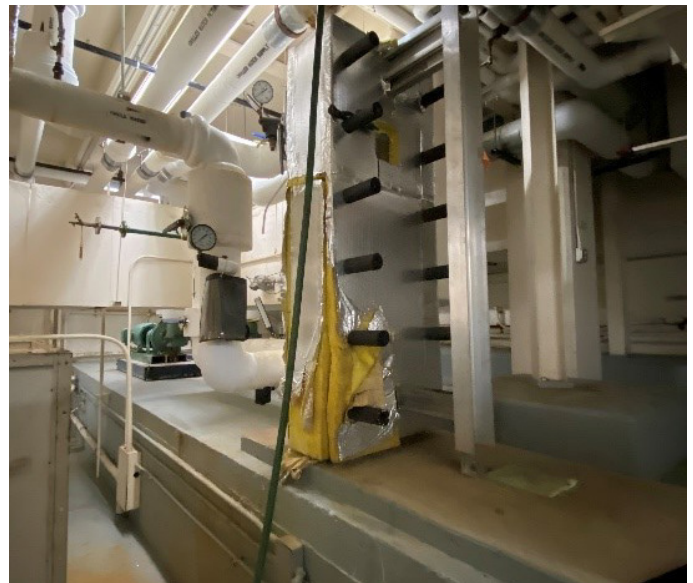
Existing heat recovery system heat exchanger abandoned in place

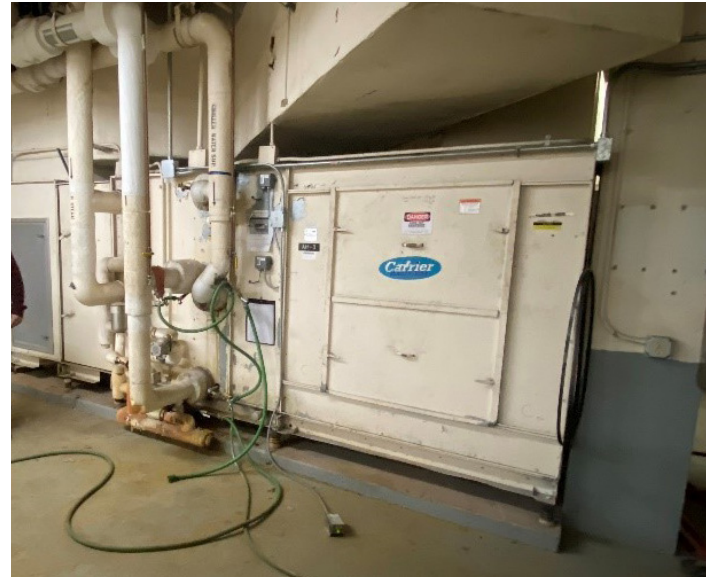
Larger 50+ year old AHU

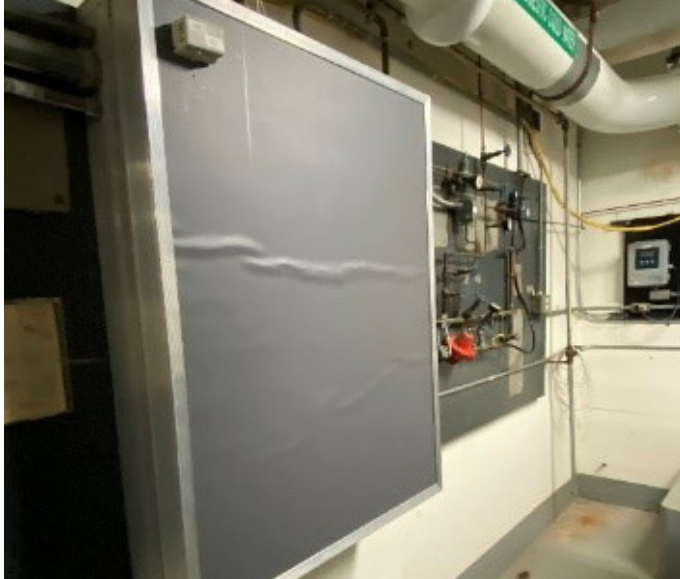
Building temperature controls are a mix of pneumatic and Direct Digital Control (DDC). The pneumatic control system is original to the building and is an obsolete technology. The pneumatic control system has exceeded its life expectancy and should be replaced new Direct Digital Controls (DDC). Pneumatic controls do not provide the level of control, monitoring and efficiency DDC controls provide today.

Original pneumatic control panel

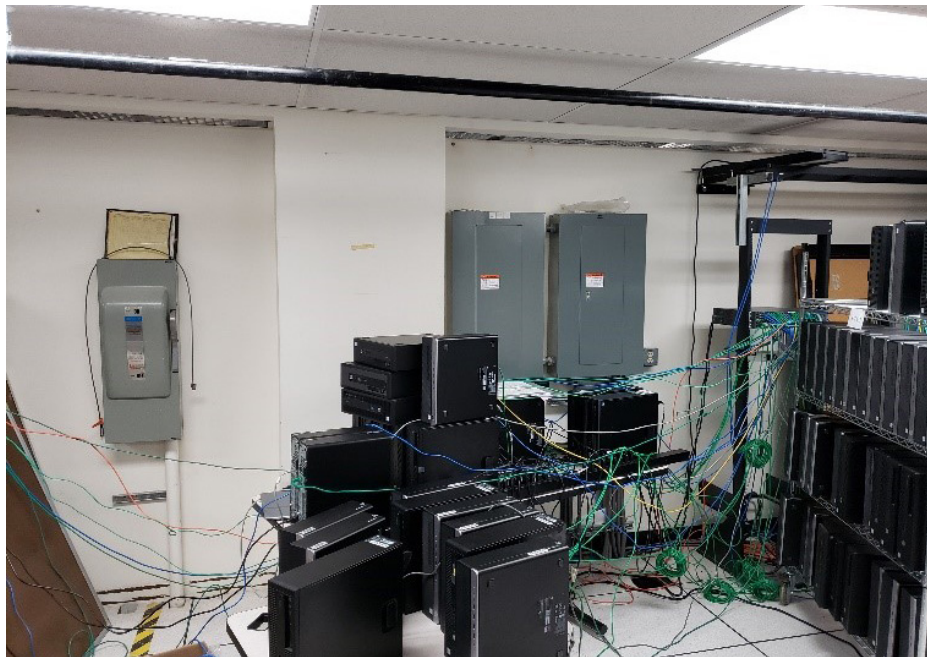
Electrical panels are of various vintages and manufactures with most being installed prior to 1980. Electrical Panels are generally at end of useful life and should be replaced. Many electrical panels are no longer in use. Significant computer equipment had been in use in the building and is no longer in use and are to be removed.

Existing Unused Panels to Support Computers

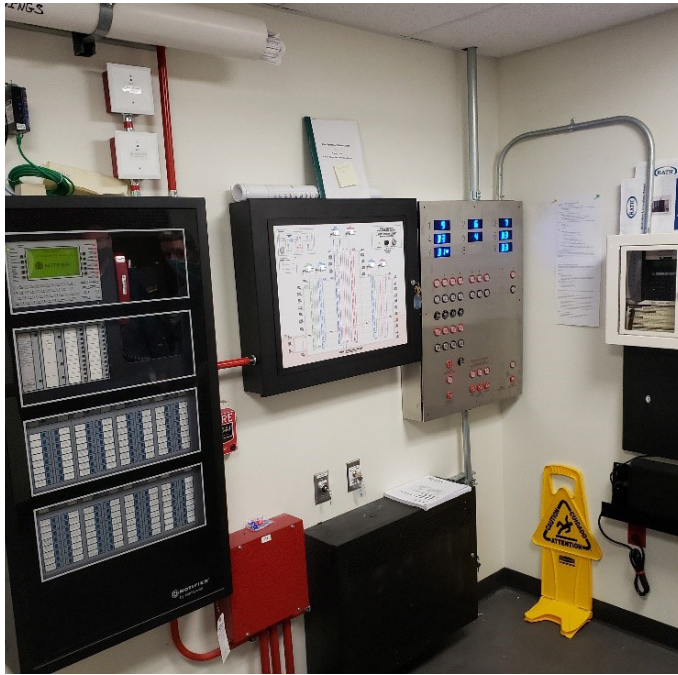
The fire alarm system is a Notifier Addressable system with Voice capability and appears to be designed for a high rise building with fireman's phones. System was installed in 1999 and the fire alarm control panel was upgraded in 2019. Facilities has indicated that fire alarm components have been piecemeal replaced and has a significant amount of old and original devices. Fire alarm system is nearing end of life and should be completely replaced.

Fire Alarm Control Panel in Fire Command Center
