GEF 1, 2, and 3 Office Building Repairs and Renovation Study

DOA # 20H2B / HGA #1190-033-01

UPDATED FINAL REPORT

JULY 27, 2022

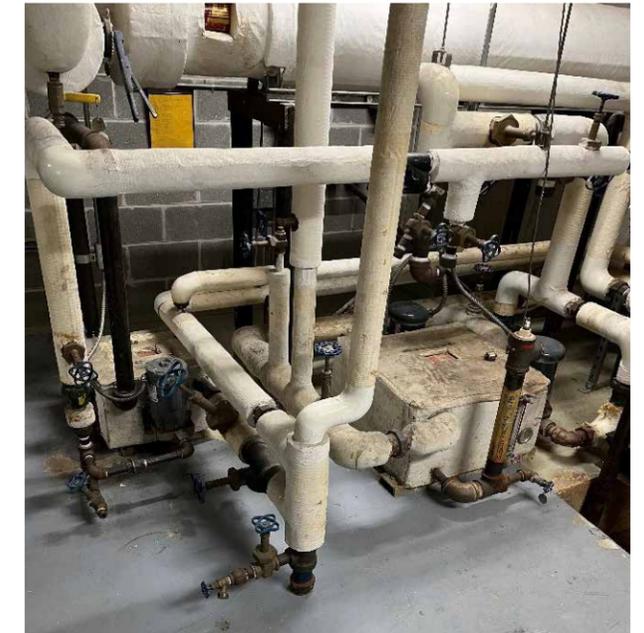
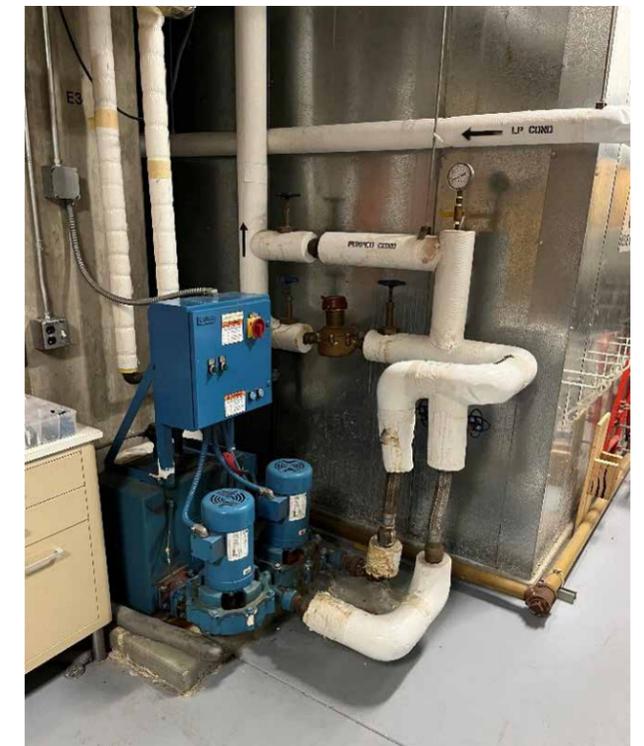
Steam Condensate Return Pumps – All steam condensate return pumps will eventually be in need of replacement. Some are in immediate need of replacement now. Recommendation is to replace all pumps as needed over time.

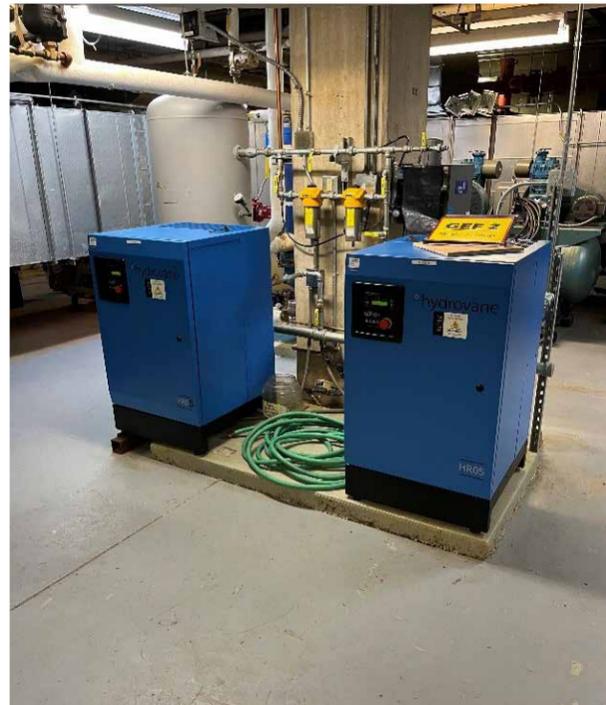
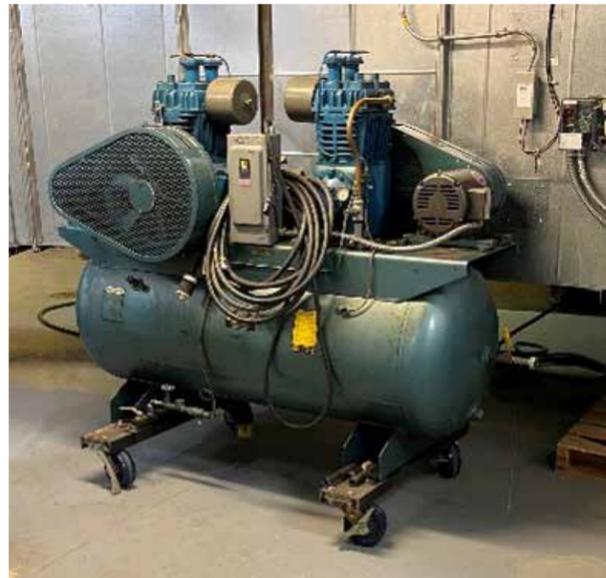
Pneumatic Controls System – All pneumatic control systems are an obsolete technology. There have been some upgrades to DDC with the addition of variable frequency drive controllers to most if not all pumps and fans. Recommendation is to replace all pneumatic controls with new state of the art Direct Digital Controls (DDC). Air compressors and dryers are no longer needed with DDC.

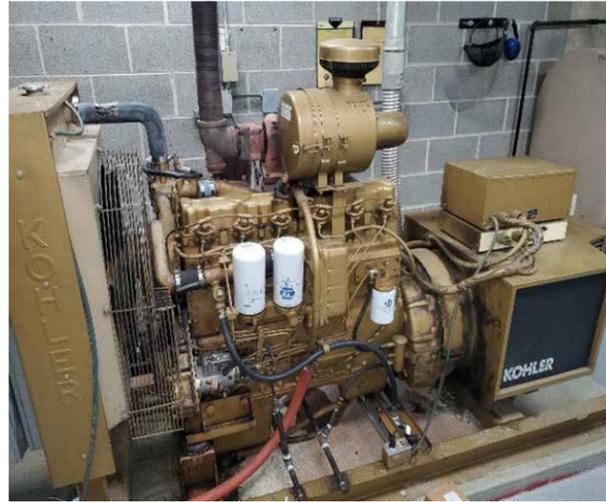
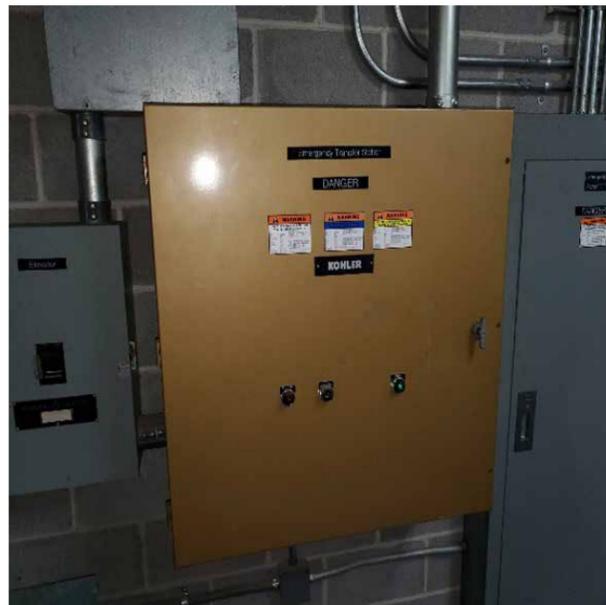
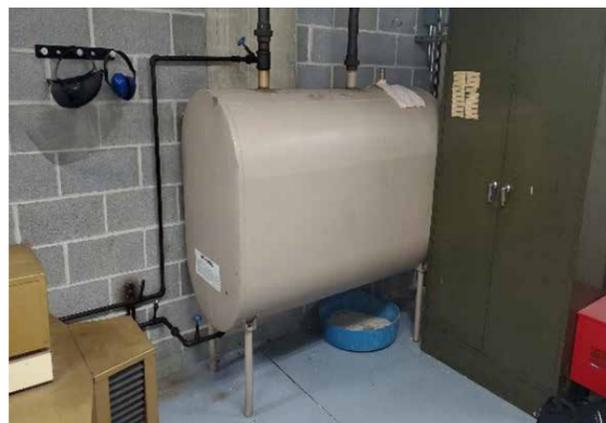
Emergency System - The building emergency generator was installed in 1978 and is in good condition, but it is approaching end of useful life. The generator is a 125 kW, 480Y/277 Volt diesel, Kohler generator. The generator fuel system is located with this room. The generator main switch is fusible, as are downstream distribution disconnects. The building has (1) transfer switch, there is not any separation of the Essential Power System into NEC 700, 701, 702, the fire pump is not fed from the emergency generator. One elevator can run on emergency power with a selector switch to select which cab can operate.

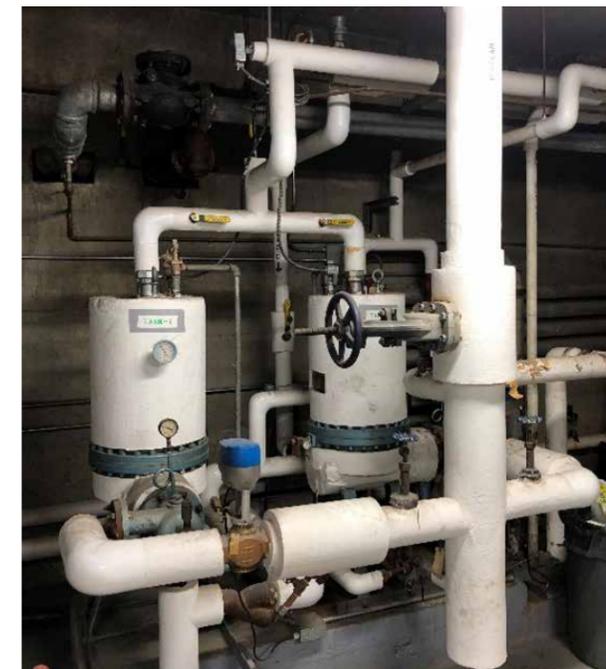
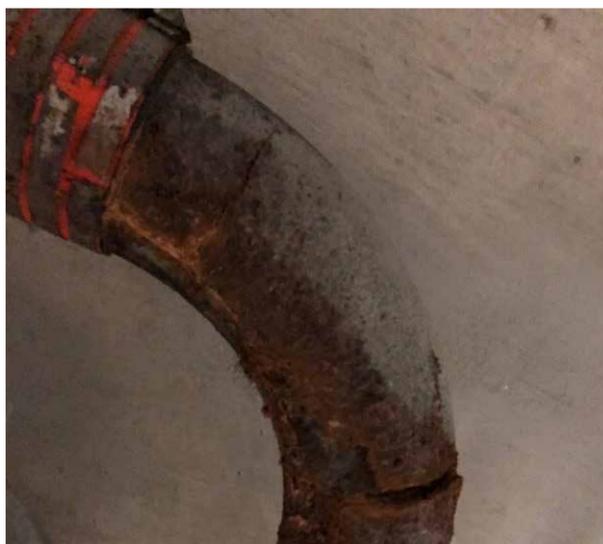
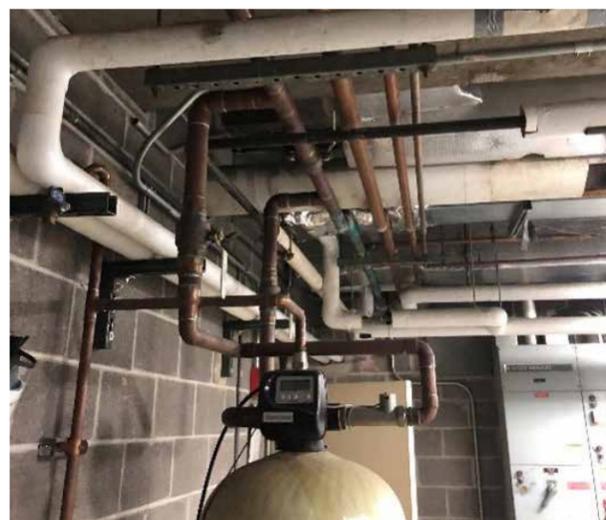
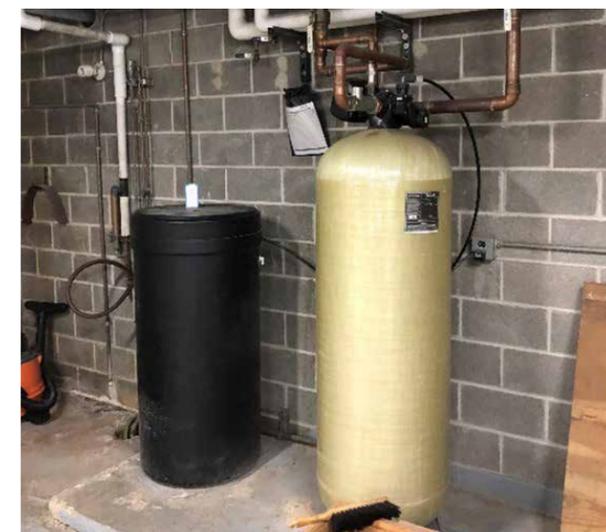
Domestic Water Piping - The copper domestic water piping system appears to be original to the building. Upon inspection, the piping is in reasonable condition. At the time of the site visit, there was no confirmation whether leaking was an issue in any portion of the building. The piping is functioning properly and serving its purpose. However, it has reached its expected life cycle. Depending on the scale of renovation, all or most of the domestic water piping should be removed and replaced. In order to ensure the longterm viability of the system into the future, it needs replacement.

Domestic Water Equipment - The steam-domestic hot water heat exchangers are original to the building and functioning properly. They appear to be in adequate condition. The water softener system appears to have been replaced since the original building construction but may be 15+ years old.

In order to achieve another several decades out of the equipment, both the heat exchangers and water softeners should be replaced with new high efficiency equipment.

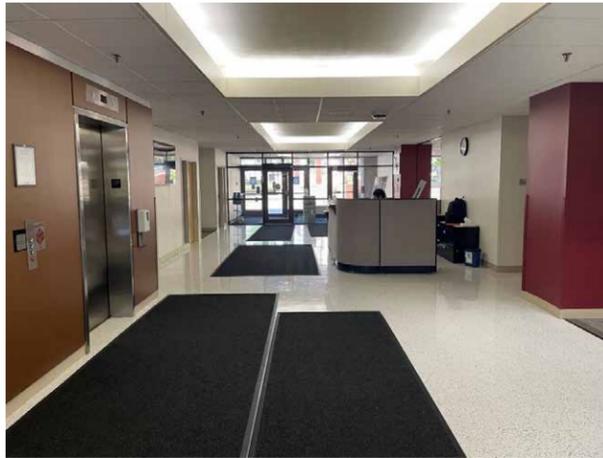
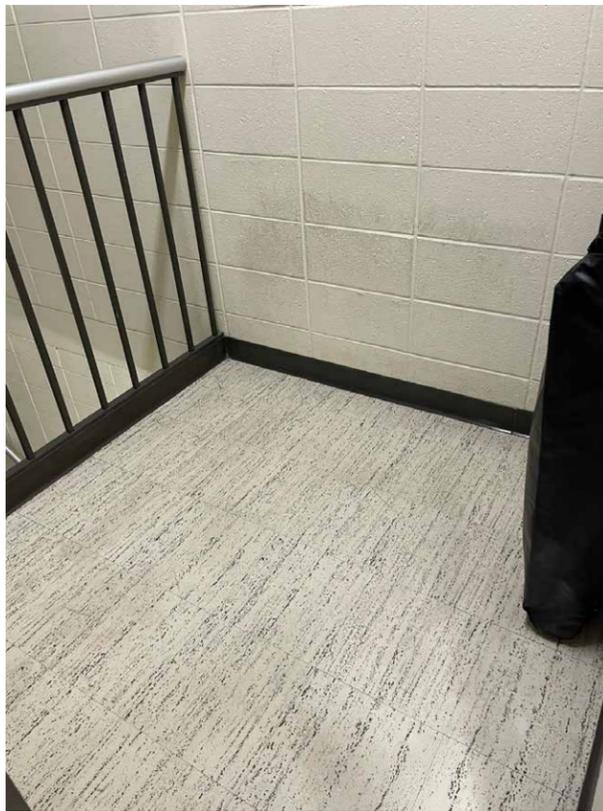
Lobby - The Lobby flooring is a terrazzo-aesthetic luxury vinyl tile that looks to be a recent installation. The walls are painted gypsum board and the ceilings are Acoustical Ceiling Tile. The stair landings appear to be an old VCT floor (would need to verify this as asbestos).

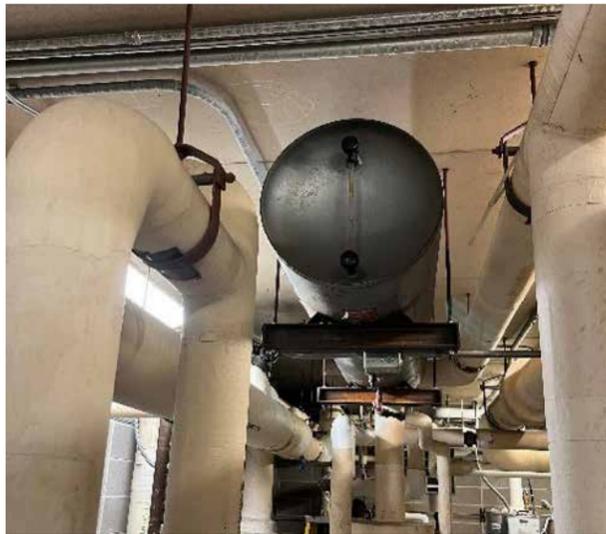
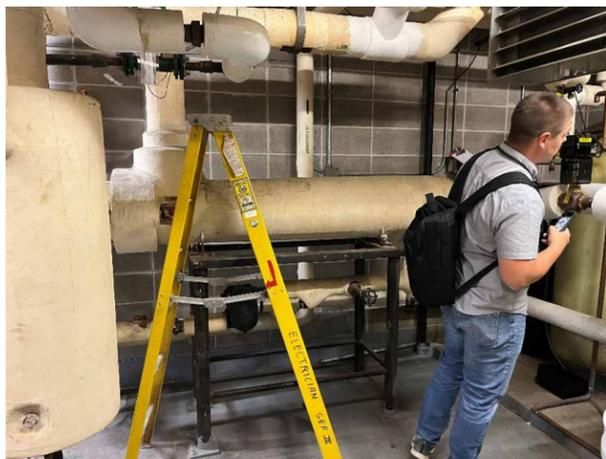
Hot Water Heating Piping Distribution – Nearly all of the hot water heating supply and return piping distribution throughout the building is original to when the building was first constructed and eventually will be in need of replacement due to deterioration from corrosion and chemical deposit build up. Recommendation is to replace all hot water heating piping.

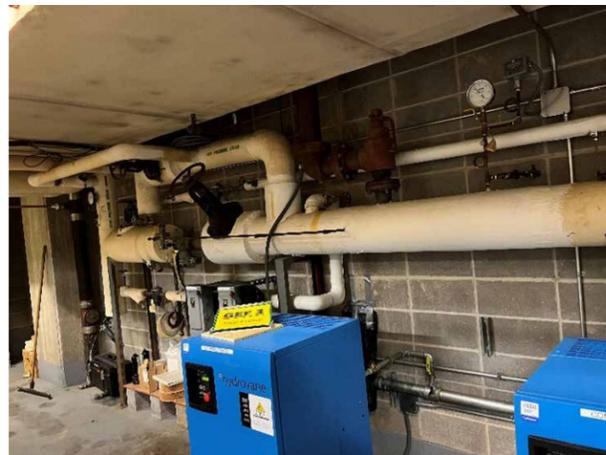
Steam Supply distribution Piping - Nearly all of the steam heating supply piping distribution throughout the building is original to when the building was first constructed and eventually will be in need of replacement due to deterioration from corrosion and chemical deposit build up. Recommendation is to replace all existing steam supply piping.

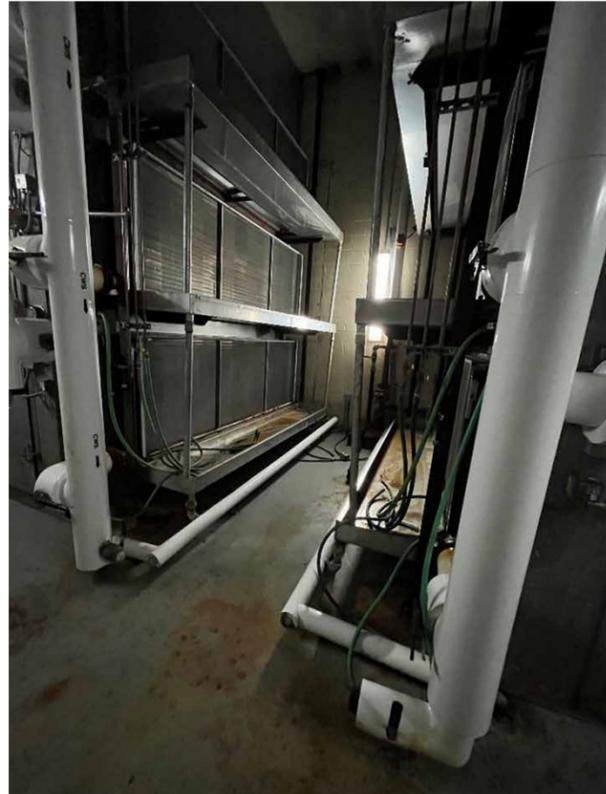
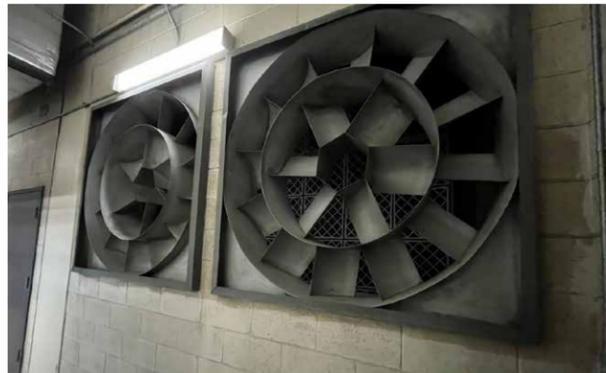
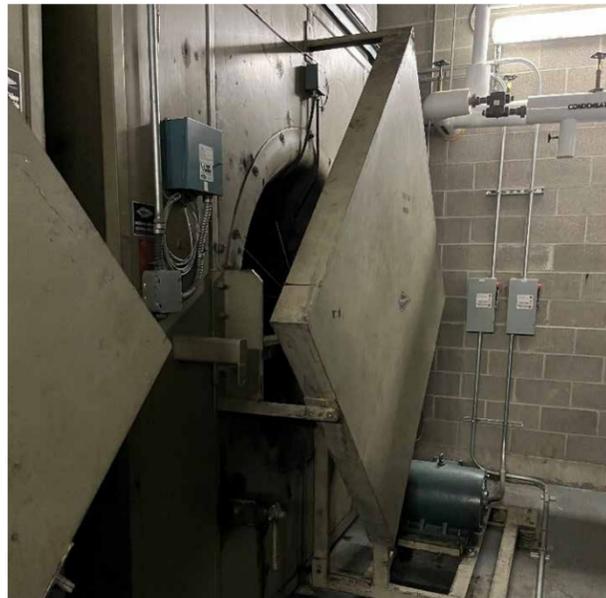
Building Air Handling Units – The main air handling unit serving this building is located in a penthouse. The design of this air handling unit is very unique in that the penthouse itself serves as the housing for the air handling unit. Most of the components in this air handling unit are original to the building when the building was first constructed. Many components including fans, filters and controls are inefficient, obsolete technology. It appears coils have been replaced some time ago and are in good condition. The use of the penthouse walls, roof and floors to serve as the air tunnel is not an efficient way to design an air handling unit. Too great a chance for excessive air leakage. Recommendation is to replace the air handling unit with a new factory fabricated unit installed in the penthouse, no longer using the penthouse as the housing.

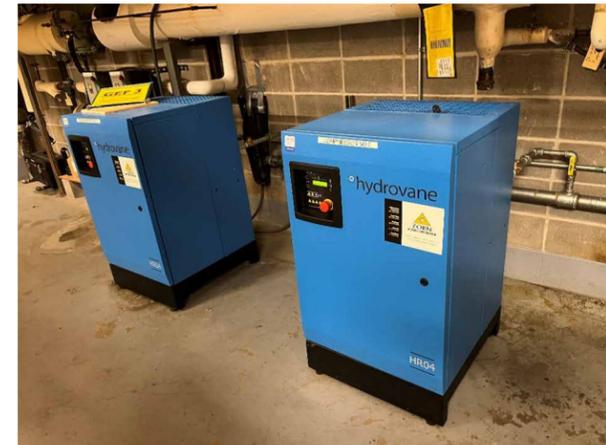
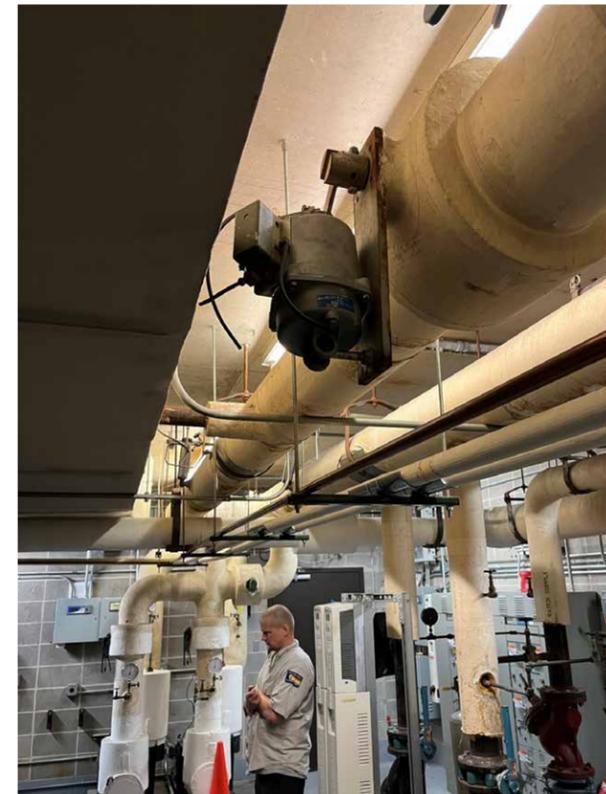
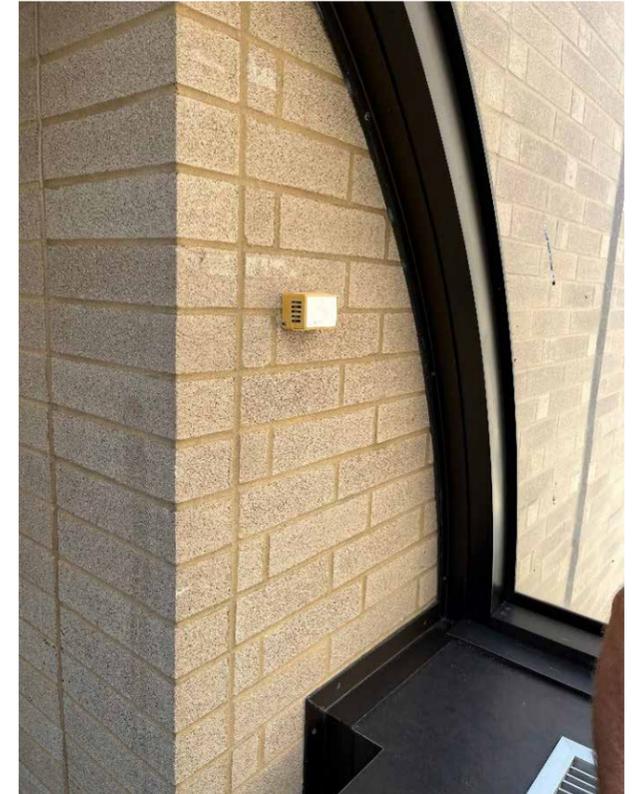
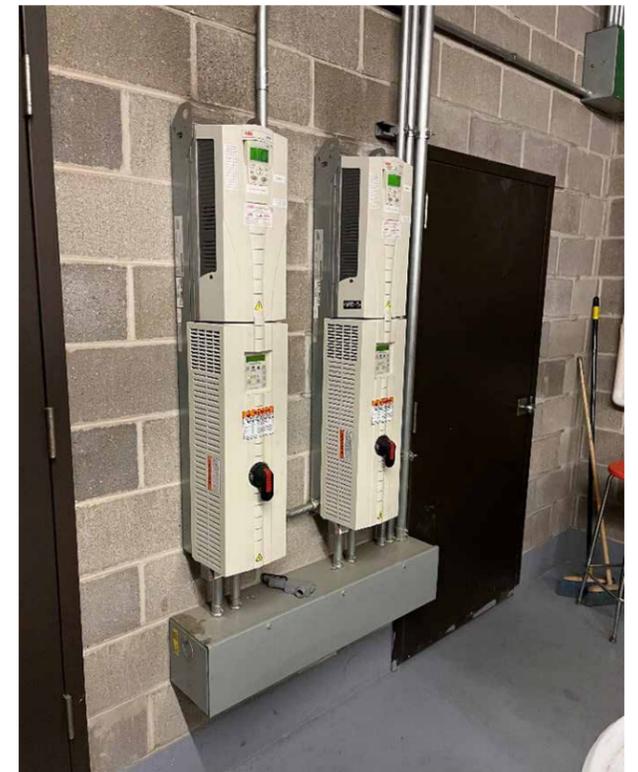
– Nearly all ductwork distribution systems in the building are original to the building when the building was first constructed. All ductwork will eventually be in need of replacement due to corrosion, excessive leakage and build up of dirt. Recommendation is to replace all ductwork distribution in the building.

Building Exhaust Fans – Nearly all building exhaust fans are original to the building when the building was first constructed. These fans are inefficient and have exceeded their life expectancy. Recommendation is to replace all exhaust fans.

Pneumatic Controls System – All pneumatic control systems are an obsolete technology. There have been some upgrades to DDC with the addition of variable frequency drive controllers to most if not all pumps and fans. Recommendation is to replace all pneumatic controls with new state of the art Direct Digital Controls (DDC). Air compressors and dryers are no longer needed with DDC.

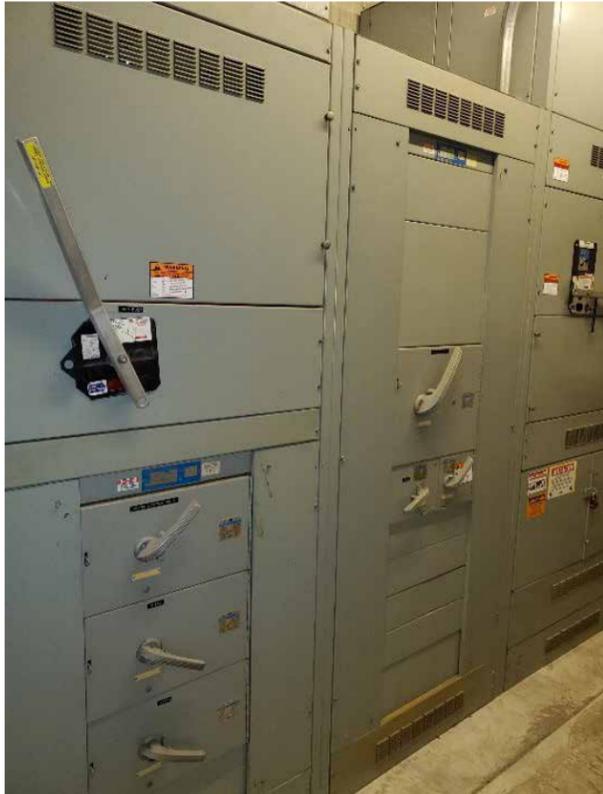
Electrical Services - The building is currently served with secondary electrical service from Madison Gas & Electric Company. Utility transformers are located in the transformer vault in this building. Service One is a 3000 amp switch with 3000 amp fuses, 480Y/277 volt, ITE fused switchgear. This switchgear is indicated as GEF2 SWGR-MN. Service Tap ahead of the main switch for Service One is a 400 amp switch with 400 amp fuses, 480Y/277 volt, ITE. This switch is indicated as B-DISC FIRE PUMP, 40HP. MG&E Peak load reading for this building is 383KW, 461 amps. Switchboards were all installed around 1978 are all reaching end of useful life.

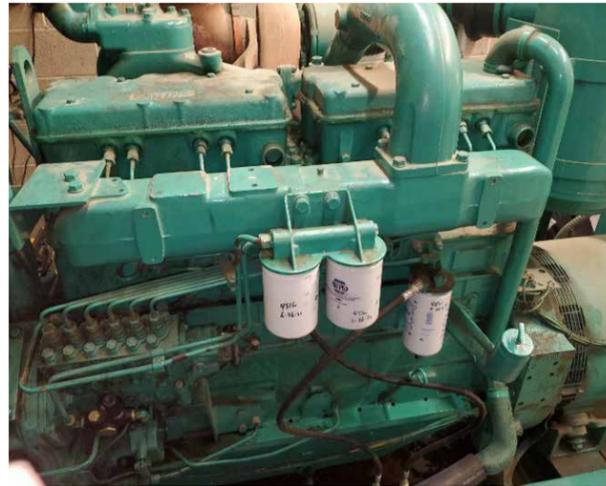
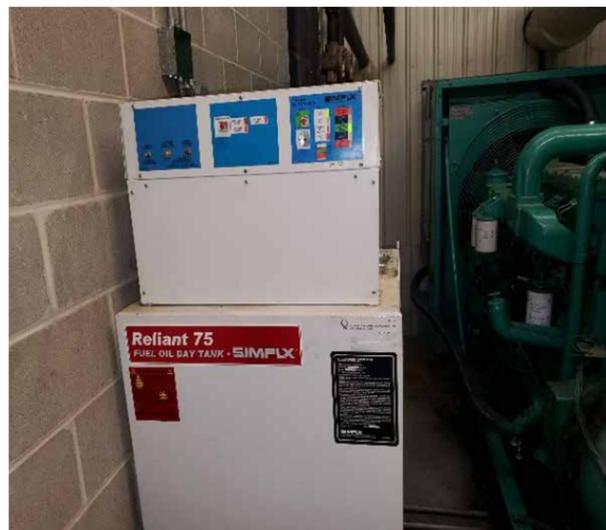
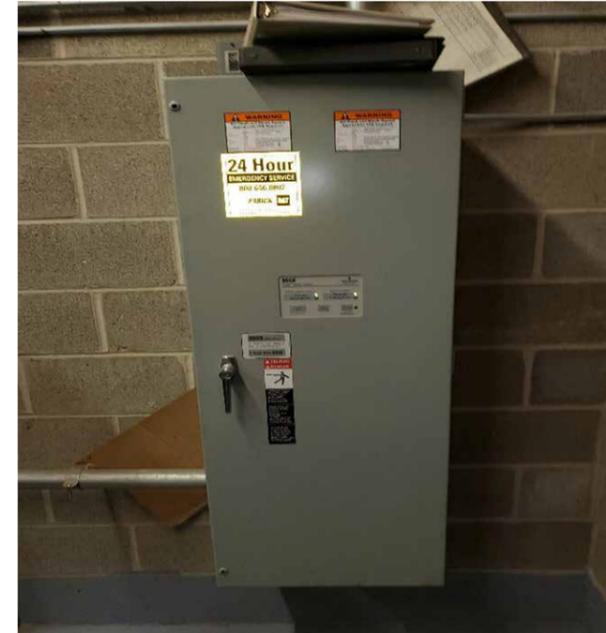
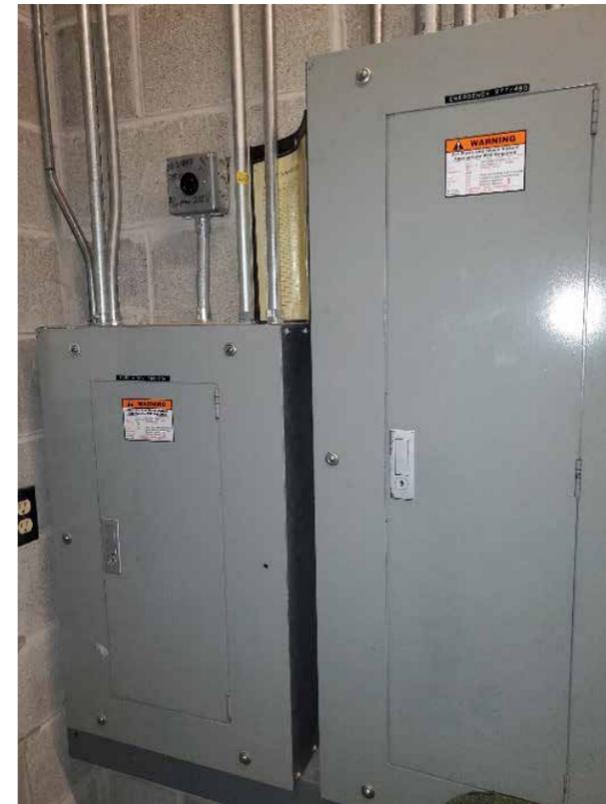
Emergency System - The building emergency generator was installed in 1978 and is good condition, but it is approaching end of useful life. The generator is a 175 kW, 480Y/277 Volt diesel, Onan generator. Transfer switch appears to be newer and in good condition. The generator fuel system is located with this room. The generator main switch is fusible, as are downstream distribution disconnects. The building has (1) transfer switch, there is not any separation of the Essential Power System into NEC 700, 701, 702, the fire pump is not fed from the emergency generator. One elevator can run on emergency power with a selector switch to select which cab can operate.

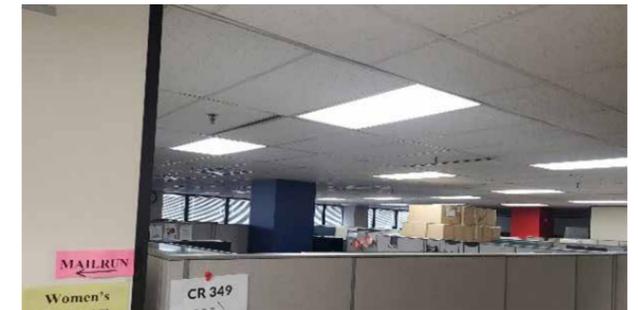
Lighting and Controls - Existing light fixtures generally were fluorescent and converted to LED with the removal of the existing lamps and ballasts and replaced with LED type lamps, which have integral driver. LED appears to have been installed during the building shut down in 2021. Exit lights appear to have been retrofitted to LED technology. Lighting controls in general appear to be manual type controls with very few automatic lighting controls observed.

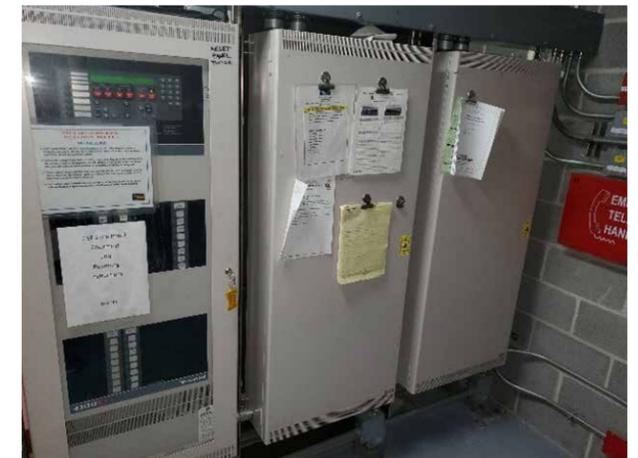
Fire Alarm System - The fire alarm system is a Simplex Addressable system. System appears to be installed in the early 2000's.

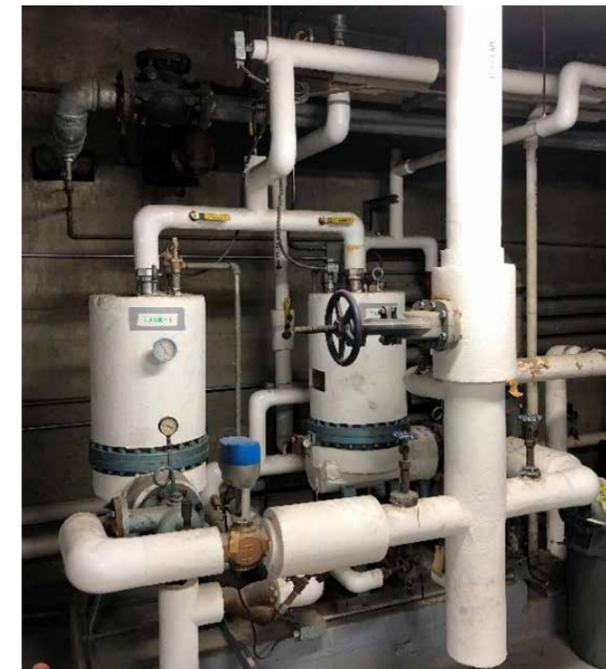
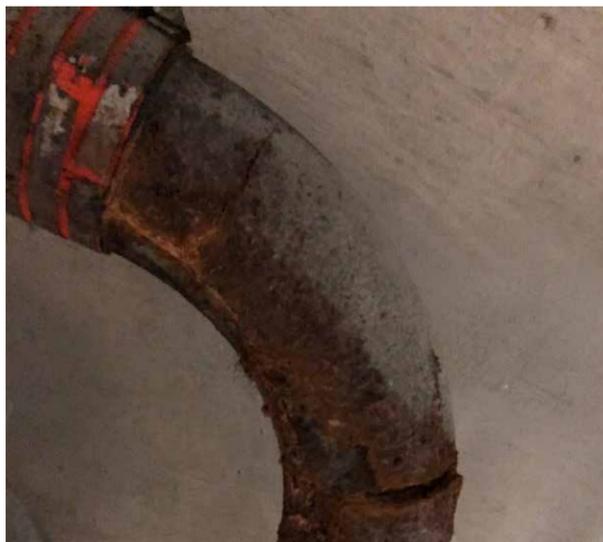
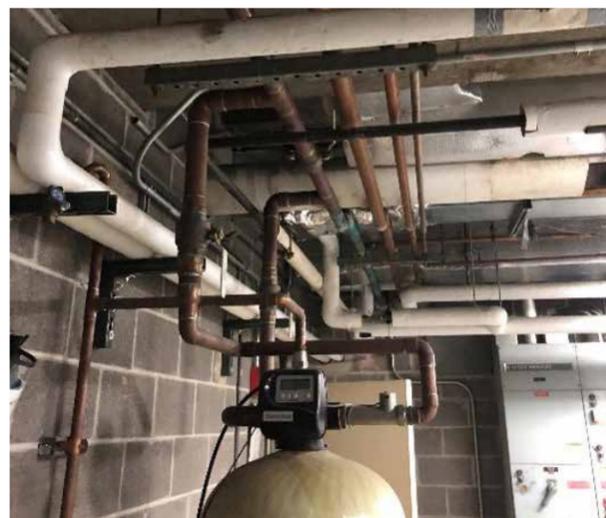
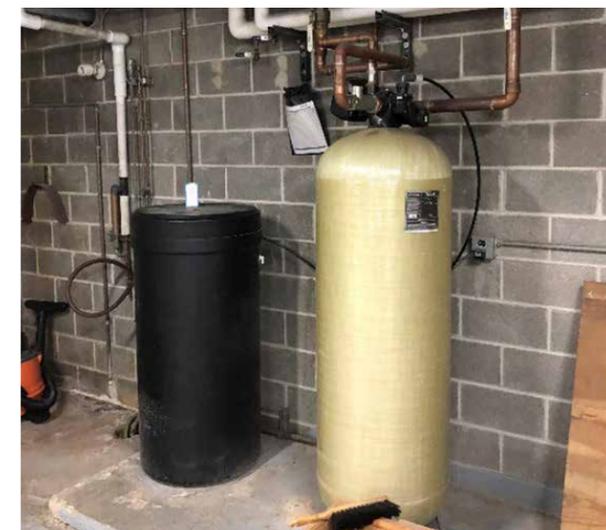
Domestic Water Piping - The copper domestic water piping system appears to be original to the building. Upon inspection, the piping is in reasonable condition. At the time of the site visit, there was no confirmation whether leaking was an issue in any portion of the building. The piping is functioning properly and serving its purpose. However, it has reached its expected life cycle. Depending on the scale of renovation, all or most of the domestic water piping should be removed and replaced. In order to ensure the long-term viability of the system into the future, it needs replacement.

Domestic Water Equipment - The steam-domestic hot water heat exchangers are original to the building and functioning properly. They appear to be in adequate condition. The water softener system appears to have been replaced since the original building construction but may be 15+ years old.

In order to achieve another several decades out of the equipment, both the heat exchangers and water softeners should be replaced with new high efficiency equipment.
