DOA # 21I2J / HGA #1190-035-00

1 WEST WILSON STREET BUILDING ASSESSMENT AND RECOMMENDATIONS STUDY

FINAL REPORT - MAY 10, 2022

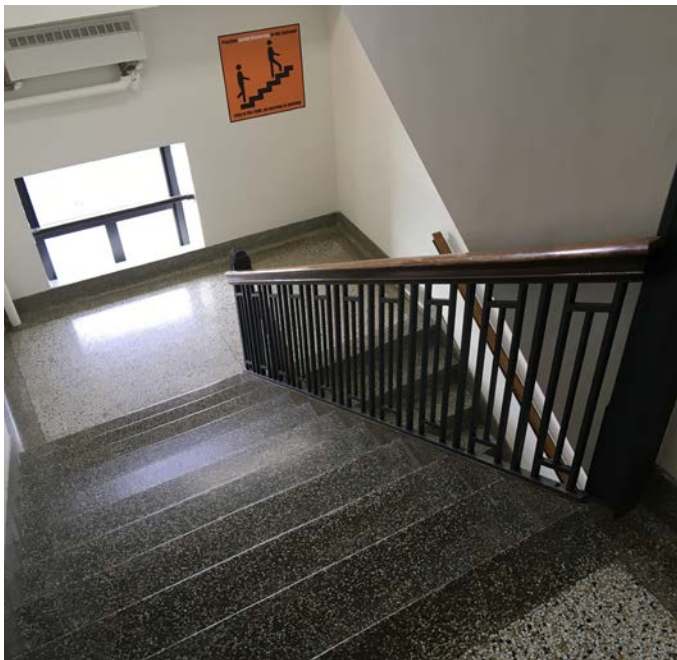
Existing Stair towers feature terrazzo and are in good condition

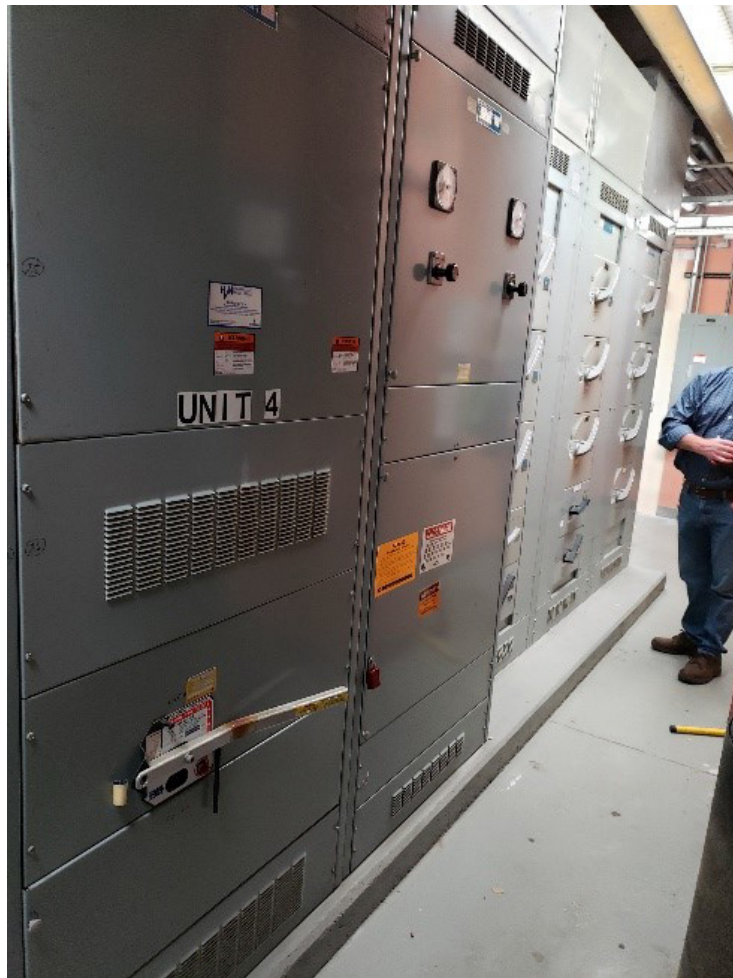
The main switch boards are all 40+ years old and reaching the end of their useful life. Many of the feeders in the building are aluminum and should be replaced. The emergency generator is new (2019), however, the branch panels should be updated. Most of the electrical panels in the building are 40+ years old and they will require replacement along with all branch circuiting.

Typical Switchboard 1-7

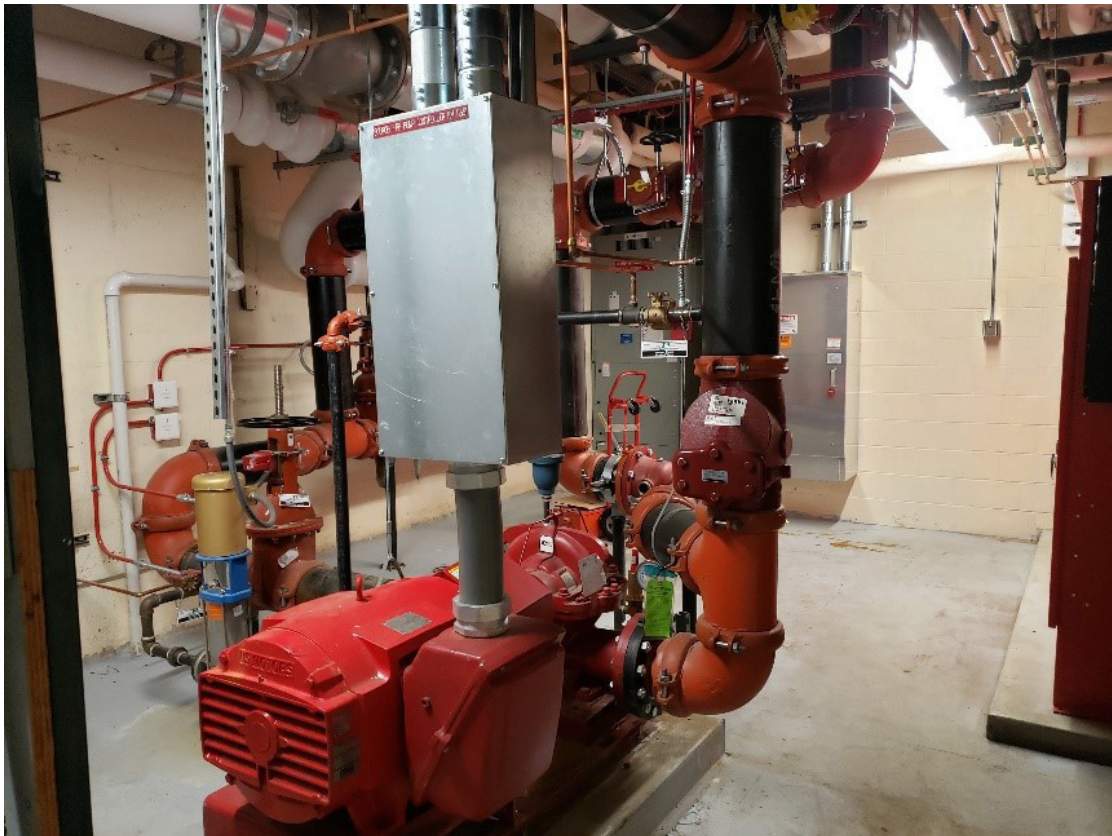
The existing fire sprinkler was installed during a complete retrofit of the building around 2018. The installation of the sprinkler system included a fire pump, fire pump controller, fire pump transfer switch, jockey pump, jockey pump controller, floor control valves, and sprinklers installed throughout the building. The existing fire sprinkler and standpipe systems are in good working condition with no discernible leaking or issues per the site investigation and discussions with building users. There are no modifications required for the system to meet the applicable codes. Modifications will be required to the fire sprinkler system to accommodate new HVAC systems and to maintain code required coverage in areas where walls and ceilings are modified. See Section 3.6 for full system review.

Fire Pump with service equipment

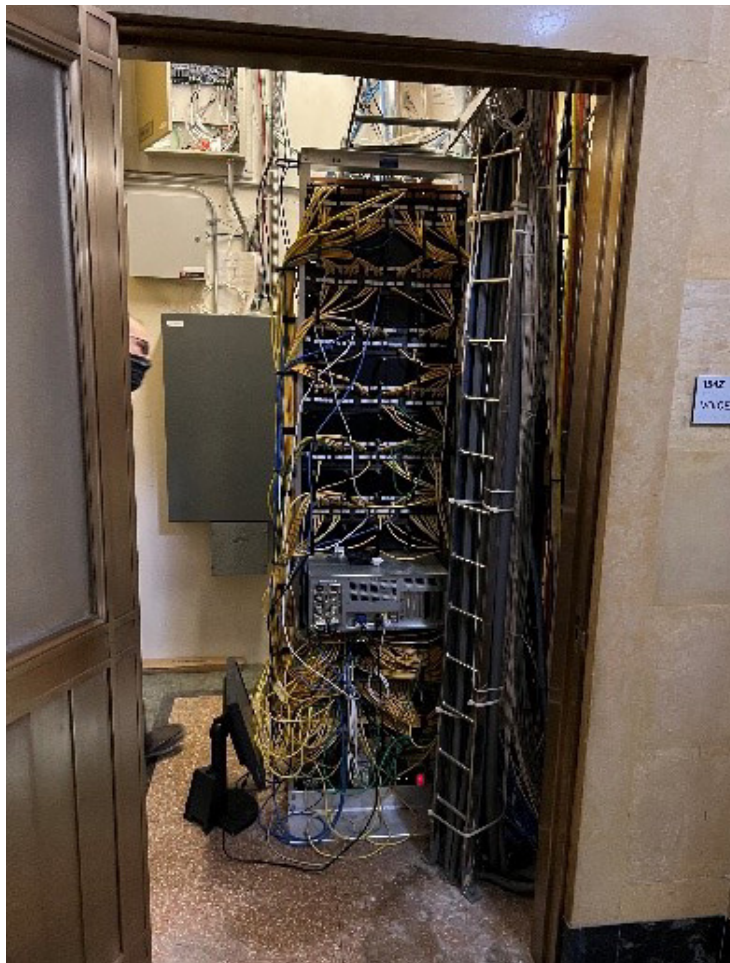
Currently, each floor is typically served by four small Telecommunication Rooms which are stacked vertically in the building. Recommendations include creating a new Main Equipment Room in the location of the current Telephone Equipment Room and consolidating the Telecommunication Rooms into two larger vertically stacked rooms per floor. Existing voice and data services and associated infrastructure shall be investigated to determine if a service upgrade is necessary based on current agency needs. Existing utility obsolete infrastructure shall be removed. All existing intra-building DET fiber optic backbone cabling terminating in 1 West Wilson shall be investigated to determine its origin, function and whether it is currently active or necessary for future connectivity. All existing intra-building cabling and terminations shall be relocation / extended to the new Main Equipment Room. All existing premise fiber optic and copper backbone cabling will be removed and replaced with new single mode fiber optic cabling. All of the existing Category 3 and Category 5 horizontal cabling will be removed from the building and replaced with Category 6A cables. The existing Emergency Responder Radio Communications System (ERRCS), US Cellular cellular reinforcement system, electronic access control system and surveillance systems head end systems are all in good condition, however cabling and locations will be modified to work with the new Telecommunication Rooms on each floor. By the time the renovation of 1 West Wilson is completed it is anticipated that the conference rooms will require an update to all of the audio visual equipment currently installed in each of the rooms. New audio visual systems will replace the existing. The requirements for the audio visual application within each conference room / space will be confirmed with the agency occupying the space at the time. At a minimum, the audio visual systems will support video teleconferencing.

Typical existing Data / Network Closet

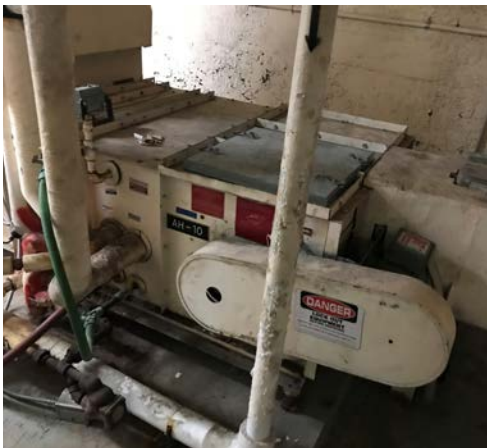
Example of decades old air handler that needs to be replaced

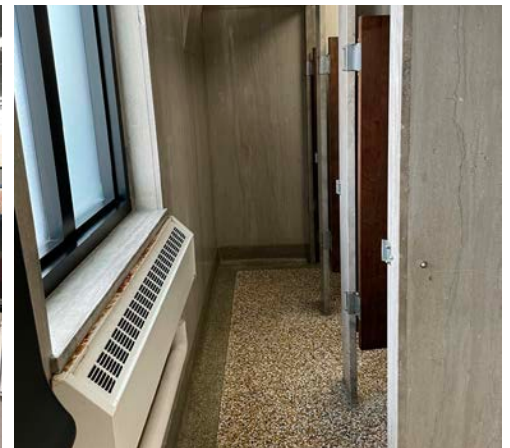
Example of existing inaccessible restroom

- **ACCESSIBILITY:** Most of the restrooms in the building are not accessible with dimensional issues at entry doors and non-compliant fixtures and stalls. The requirement to replace all of the plumbing piping again presents the opportunity to greatly improve accessibility in the restrooms throughout the building.

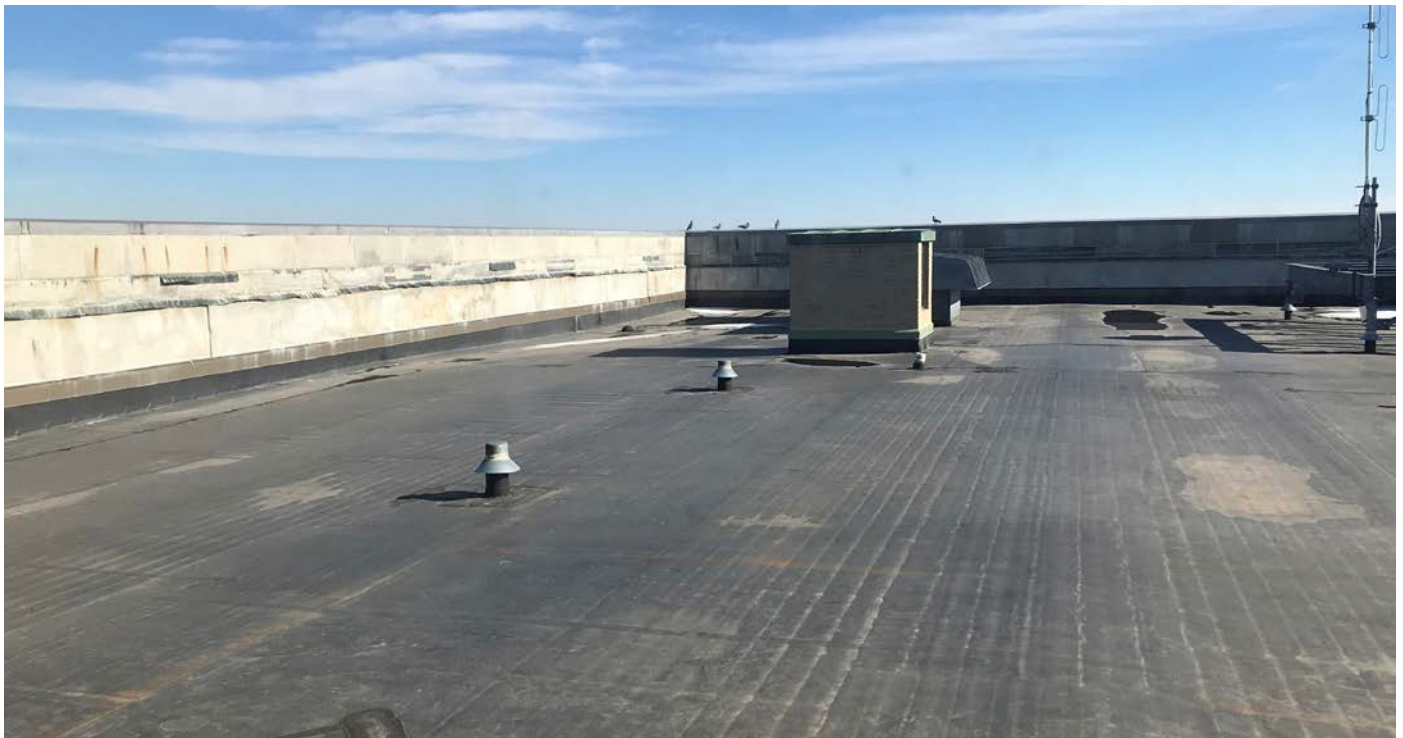
Existing rooftop of central tower is the location of a proposed mechanical air handling unit. The tall parapet will help conceal the unit.

For the mechanical penthouse proposed for the 11th floor, a structural engineer will need to verify the capacity of the existing roof and columns.

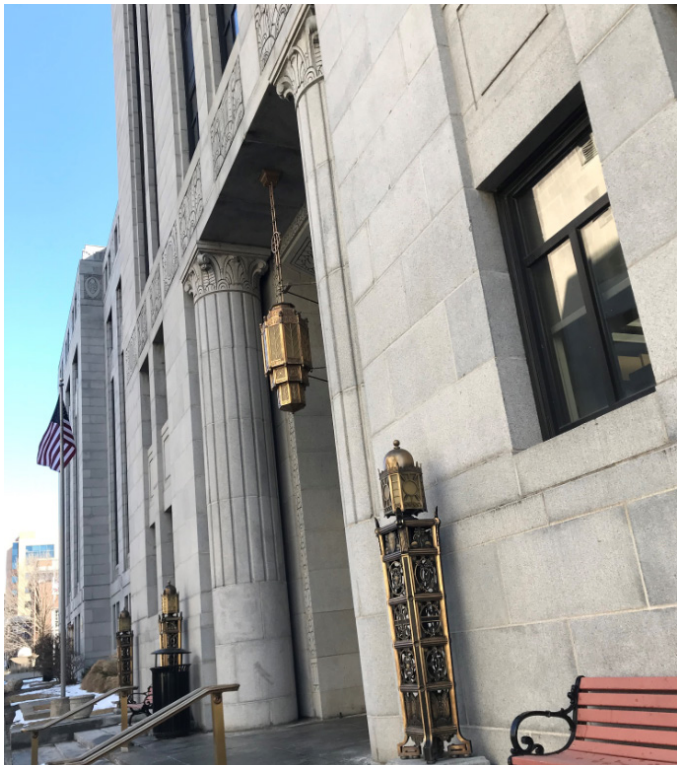
Exterior of 1 West Wilson is in good condition

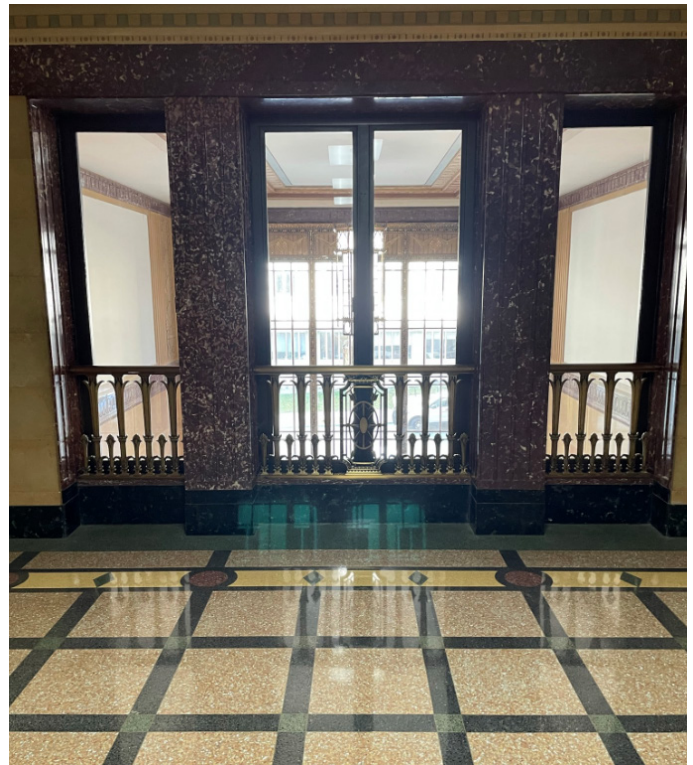
Historic areas are in good condition requiring little work

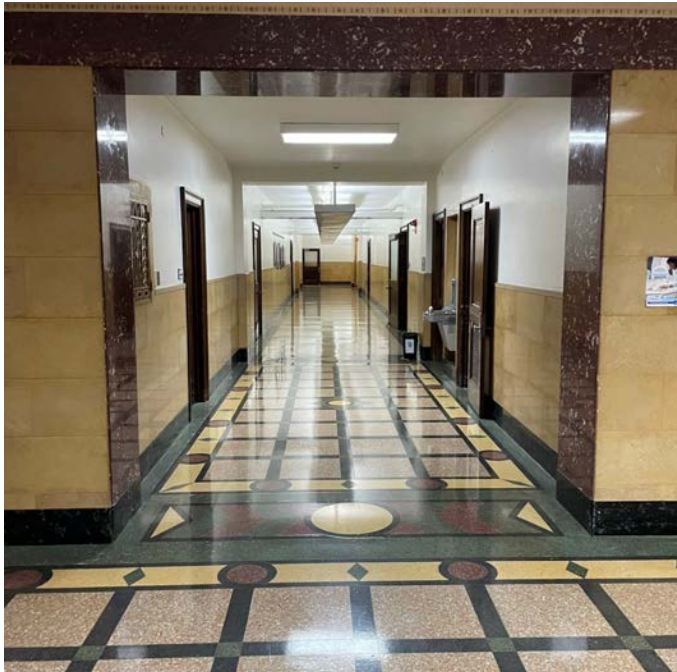
The building interiors in the Public Corridors consist of marble walls, ornamental wallcovering in specific areas and Terrazzo Flooring and base. The walls and floors are in very good condition given their age. Toilet Rooms also consist of marble walls and toilet partitions, and terrazzo flooring and base. The base in some areas is integrated into the toilet partitions.

Main Corridor showing marble walls and terrazzo floors/base

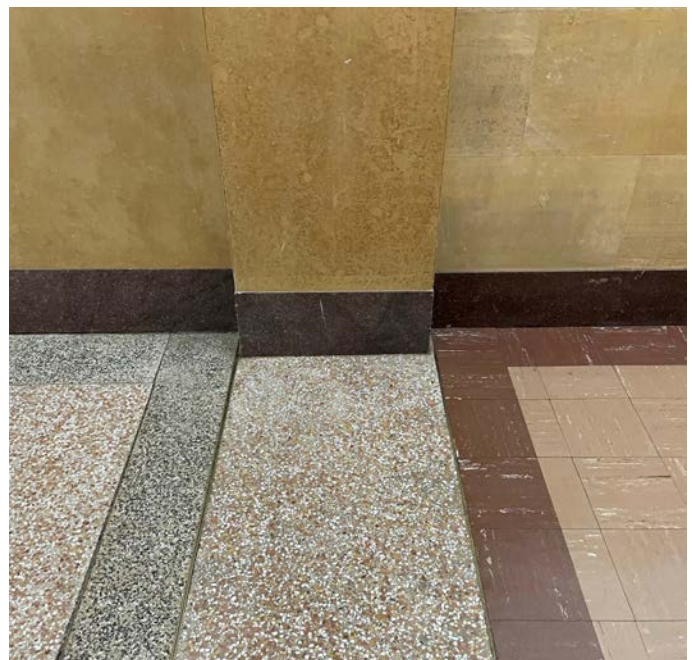
Flooring where terrazzo meets VCT

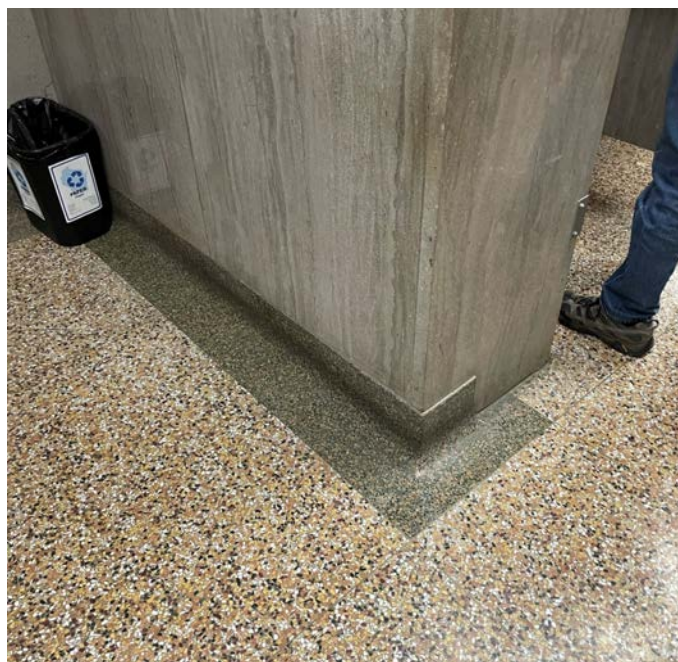
Toilet Room terrazzo floors, integrated base into toilet partition

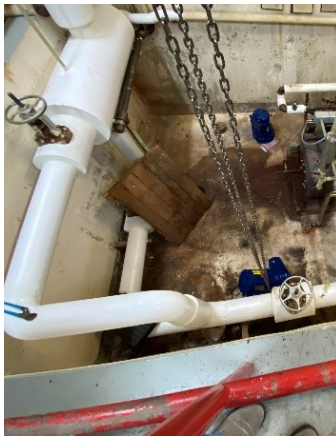
Low pressure steam condensate is returned via combination of two methods. Vacuum condensate pump units and conventional condensate transfer pumps. All units appear to have been replaced at some point in the life of the building. However, all are in fair to poor condition requiring constant service and repair.

Typical condensate transfer pump in pit; Typical vacuum pump unit in pit

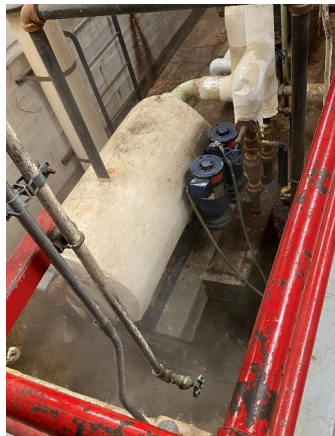
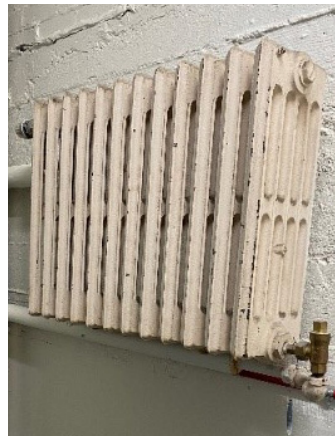
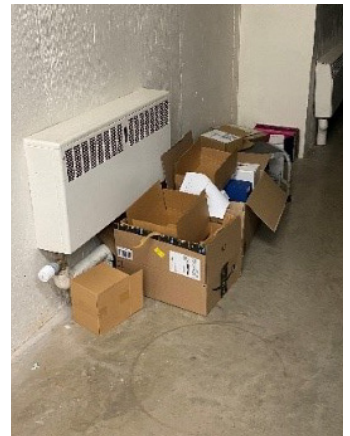
Low pressure steam and condensate is distributed throughout the building to air handling units and perimeter heating terminals. Many of the existing heating terminals are original to the building and have exceeded their life expectancy. Many original heating terminals have been replaced somewhere in the life of the building and too have reached their life expectancy.

Typical steam original cast iron radiator; Typical radiator replaced with convector

Many of the existing steam system zone isolation valves have poor accessibility or are completely inaccessible. The existing steam distribution systems have reached their life expectancy and should be replaced with a new hydronic heating system.

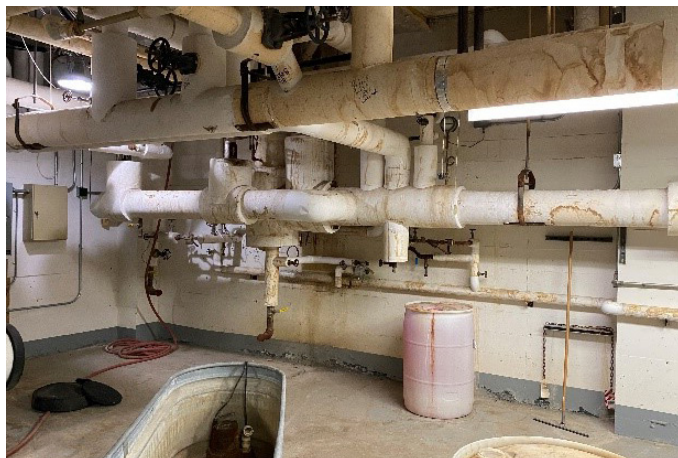
The existing building heating system is supplied low pressure steam from the Capitol Power Plant. Steam enters the building via an underground steam tunnel system. Steam is distributed throughout the building and provides for all building heating needs. All heating devices use steam. Much of the steam distribution system is original to the building and in constant need of service and repair.

Steam service in basement

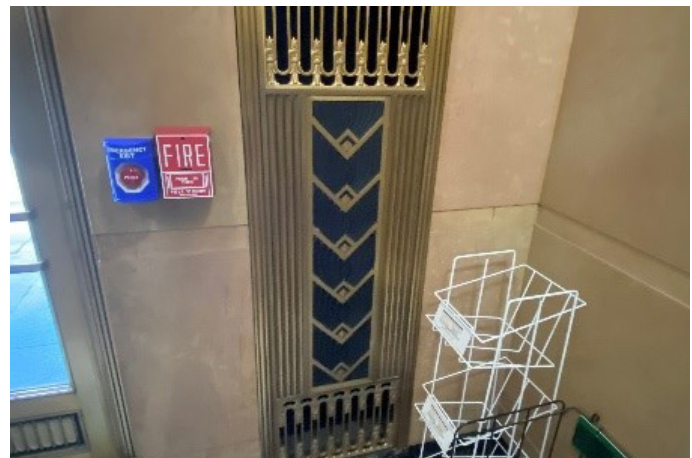
One aspect of the existing heating system with regards to historical preservation if possible, is keeping some of the original ornate grilles used to house cast iron steam radiators.

Main entrance steam radiators behind ornate grilles

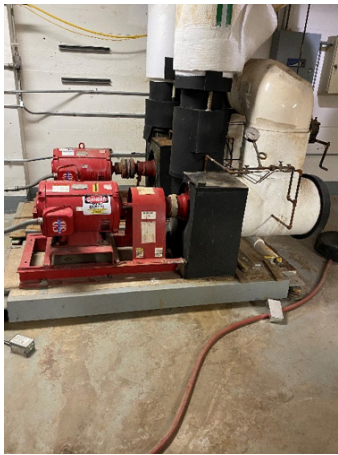
The building is cooled with a chilled water system. Chilled water to the building is supplied from the Capital Heating Plant. Chilled water pumps in the building circulate chilled water throughout the building to cooling coils in air handling units. The existing chilled water pumps appear to be in fair condition. Much of the existing chilled water piping distribution is original to the building when chilled water was first installed and appears to be in fair to good condition.

Building Chilled Water Pumps

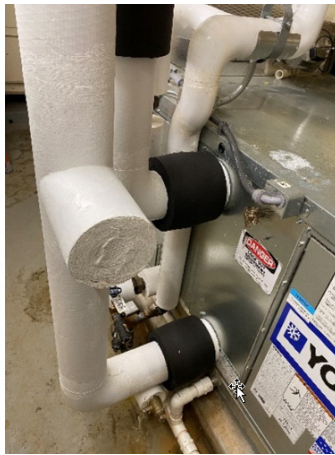
Newer Chilled Water Piping

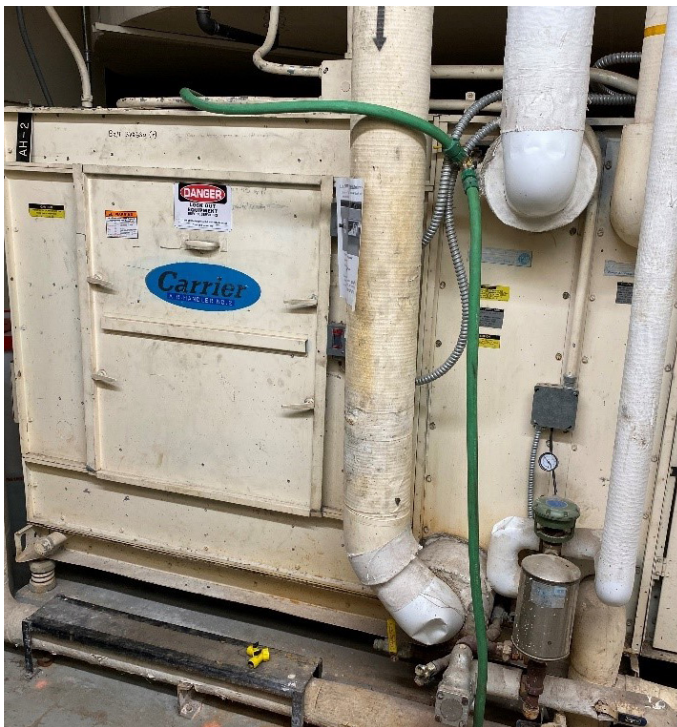
Older Chilled Water Piping

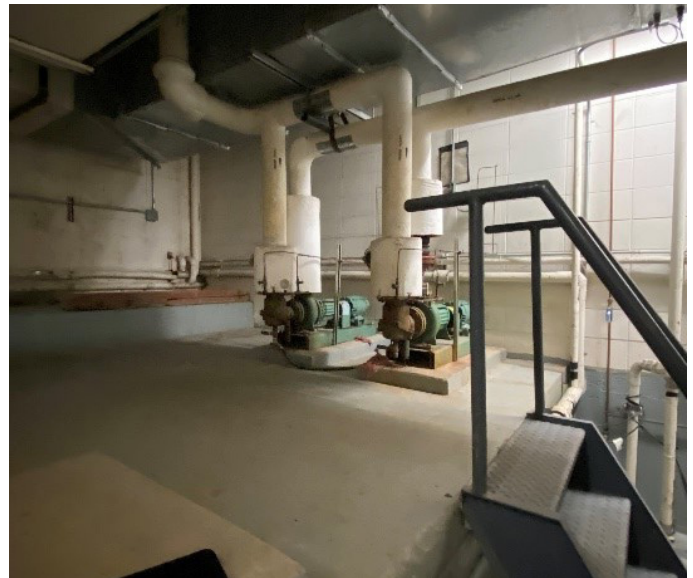
There is an existing hydronic dry cooler system installed in the building that was used to serve water cooled computer room AHU's. This system was decommissioned some time ago and is abandoned in place. The system consists of pumps, heat exchanger, fluid cooler and piping distribution. This system is obsolete and should be removed.

Existing heat recovery system pumps and piping abandoned in place

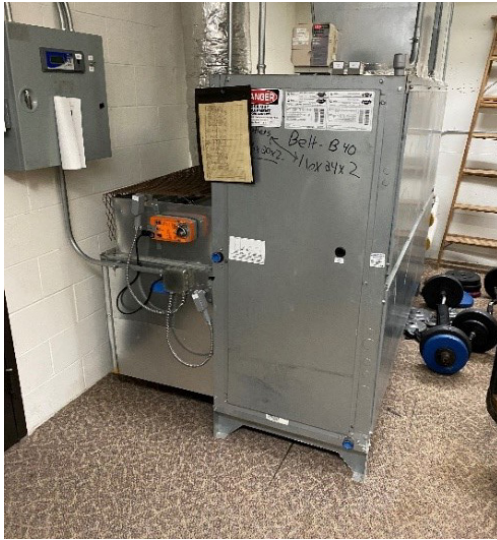
Small fairly new AHU

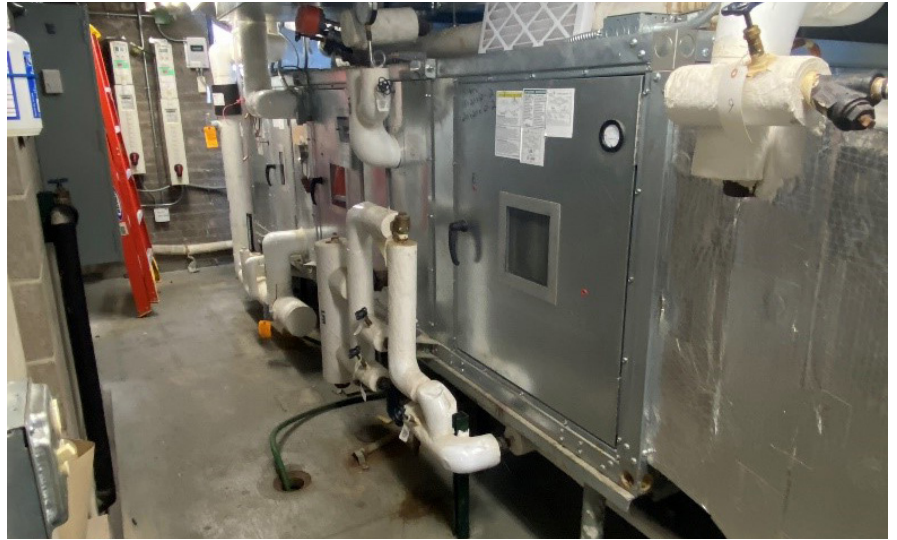
Fairly new larger AHU

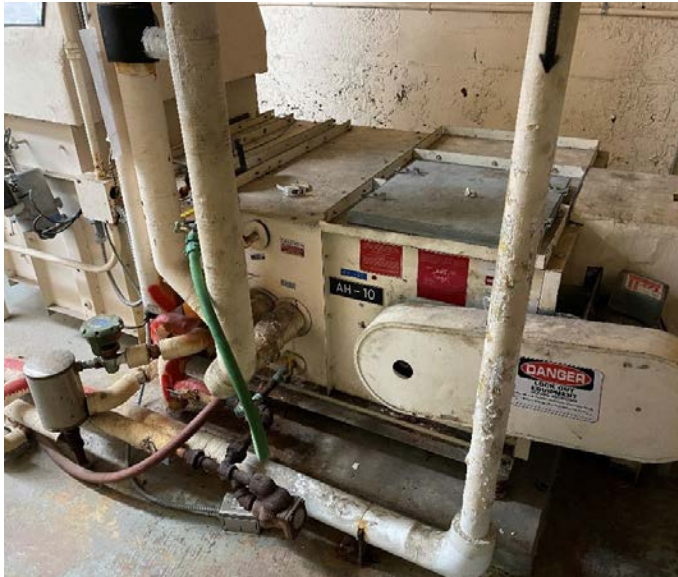
Small 50+ year old AHU

All of the older air handling units have exceeded their life expectancy and are not equipped with features commonly available with air handling units manufactured today. These old AHU's only have 2-inch-thick pre-filters with no final filters, no access between heating and cooling coils, no access at humidifiers, single belt driven fans providing no redundancy and are overall less efficient.

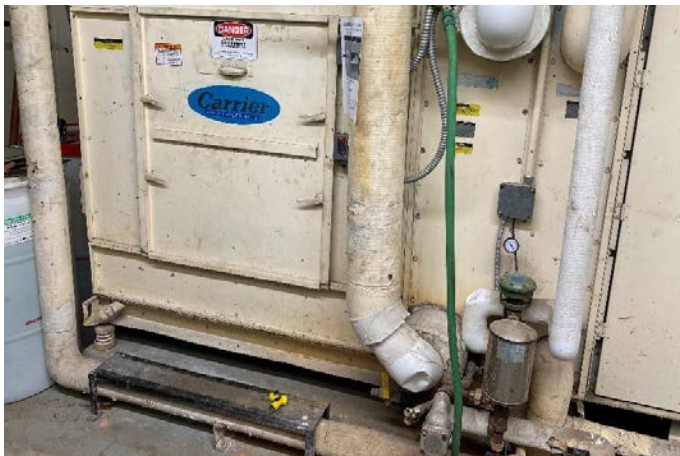
Example of old AHU with no access between heating and cooling coils or humidifier

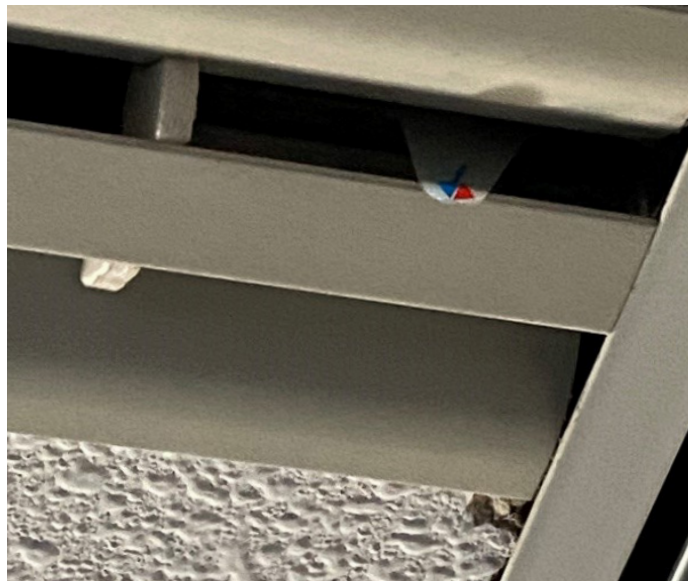
Moduline supply diffuser with manual adjustment tab for heating and cooling supply air control.

Much of the building is served by a modulating supply diffuser system manufactured by Moduline. This is an obsolete technology and is experiencing significant failures. Replacement parts are becoming more and more difficult, and costly to obtain. This system should be replaced with a new VAV with reheat system.

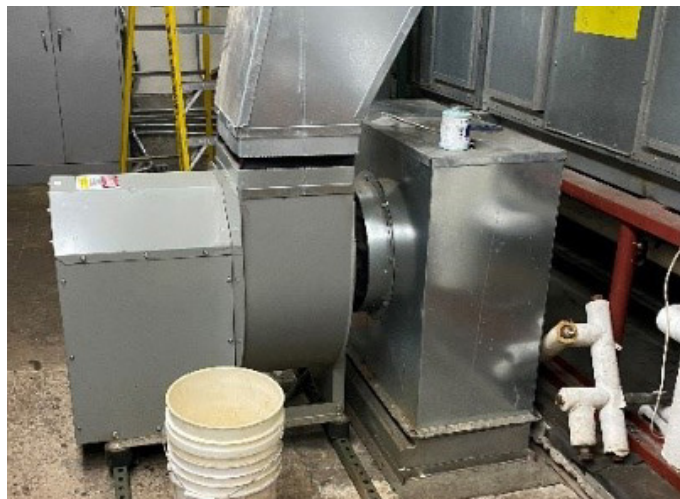
Ventilation exhaust is provided in the building. Much of the exhaust systems appear to have been added over time with many of the exhaust fans replaced over time. It is most likely that the amount of exhaust provided by these systems does not comply with current code.

Typical utility set exhaust fan

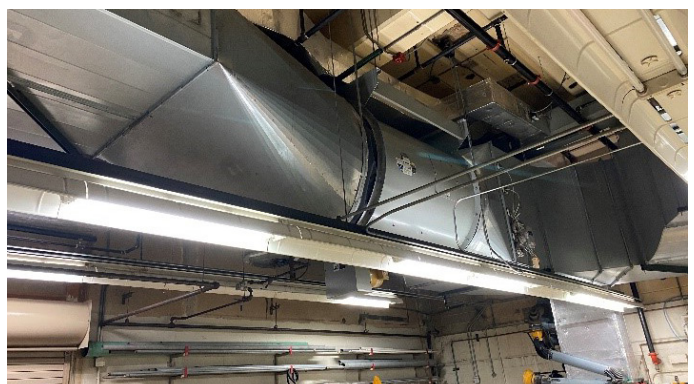
Typical inline exhaust fan

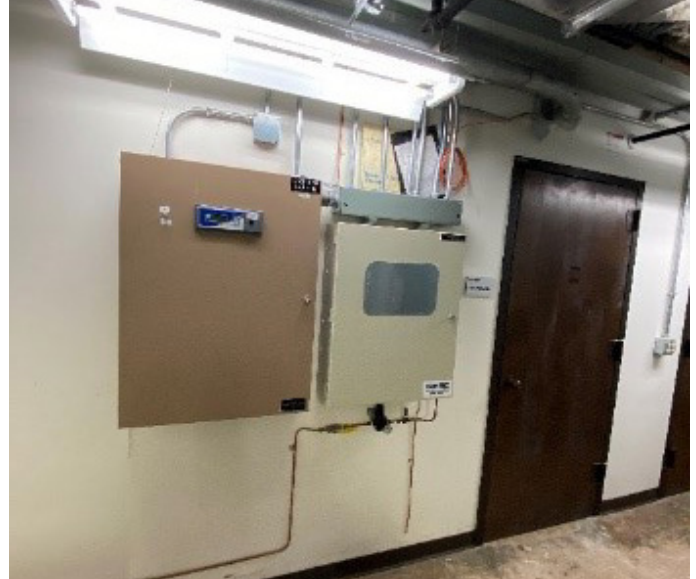
Building temperature controls are a mix of pneumatic and Direct Digital Control (DDC). The pneumatic control system is original to the building and is an obsolete technology. The pneumatic control system has exceeded its life expectancy and should be replaced new Direct Digital Controls (DDC). Pneumatic controls do not provide the level of control, monitoring and efficiency DDC controls provide today.

New DDC panel next to old pneumatic panel

All existing controls in the building should be removed and replaced with new. This includes all existing pneumatic controls, existing electric controls, and existing Direct Digital Controls (DDC). All new controls will be latest state-of-the-art DDC.

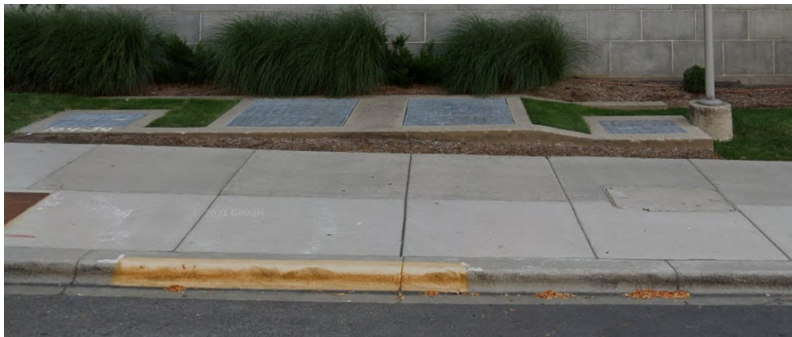
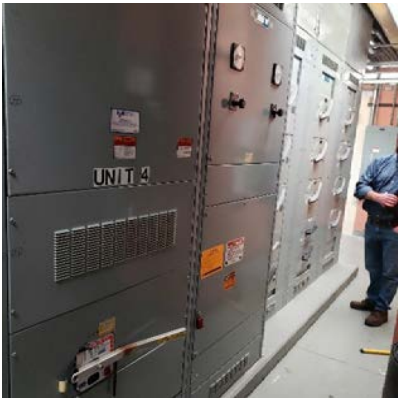
Typical Switchboard 1-7

all installed around 1982 are all reaching end of useful life. Degradation of some of the equipment due to moisture was observed.

It was noted that many of the electrical feeders in the building were Aluminum. These wires were manufactured prior to the current “compact strand” Series 8000 type that was developed to greatly reduce the problems found in earlier products. These feeders should not be reused.

- Provide (2) new MG&E electrical services to replace the (2) services that currently serve Switchboards 1-7.
- Estimated service size for each is 2500A, 208Y/120V. Switchboards are to be fusible to account for high available fault current from the downtown utility loop.

All 7 of the existing Fusible Switchboards were installed in the late 1970's or Early 1980's and are nearing end of useful life and are to be replaced.

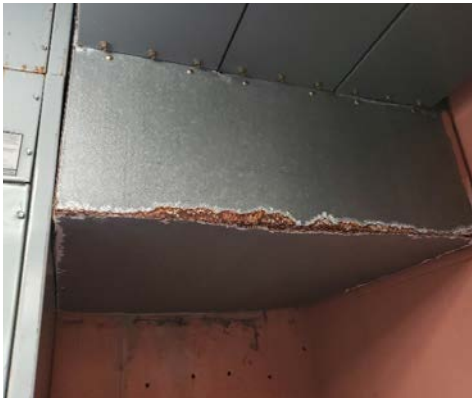
Moisture degradation of Electrical Service Equipment

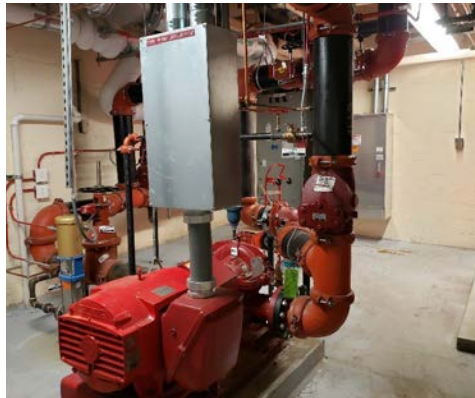
The third service serves the building fire pump and was installed 2018. The service is 208Y/120 Volt and Peak Demand is 88kW. This service is in good condition and is intended to remain.

Fire Pump with service equipment

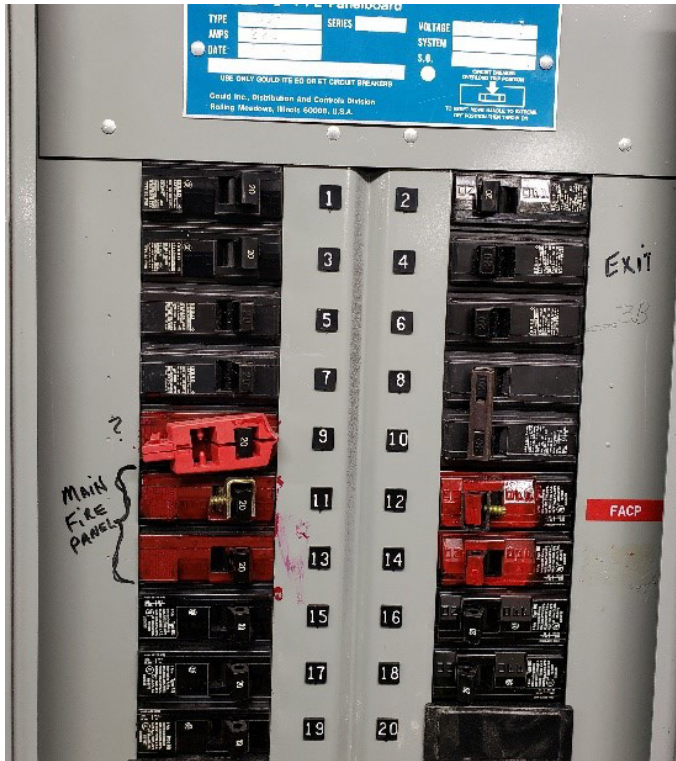
Existing Emergency Panel

Electrical panels are of various vintages and manufactures with most being installed prior to 1980. Electrical Panels are generally at end of useful life and should be replaced. Many electrical panels are no longer in use. Significant computer equipment had been in use in the building and is no longer in use and are to be removed.

All existing electrical panel boards and distribution panels are of similar vintage are to be replaced.

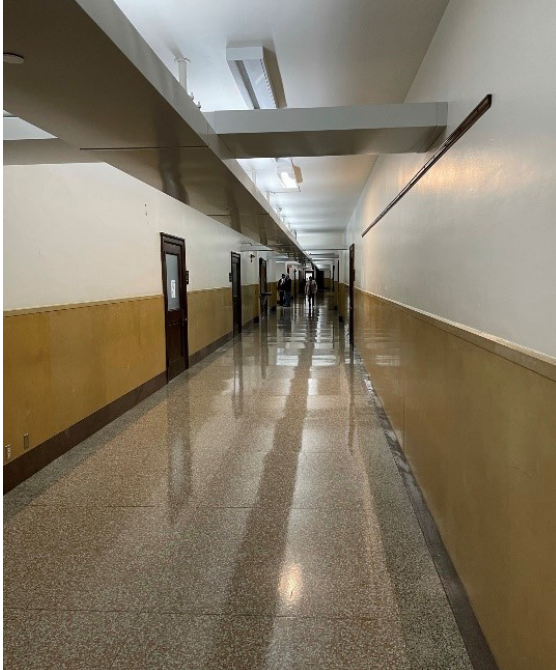
Main Corridor Lighting

Existing light fixtures generally appear to be fluorescent, with some LED retrofitted fixtures in the common areas. Both T8 and T12 style fluorescent lamps were observed. LED appears to have been installed as part of the generator installation in 2019. Exit lights appear to have been retrofitted to LED technology. Lighting controls in general appear to be manual type controls with very few automatic lighting controls observed. Significant energy savings and reduction in ongoing maintenance would be achieved by utilizing LED technology and the addition of automatic lighting controls

- Provide LED retrofit of existing "Historical" light fixtures in the entry lobby and public corridors.
- Provide new LED lighting in all areas of the building.
- Lighting levels to meet recommended levels as established by the Illuminating Engineering Society of North America (IESNA) based on the use of spaces within the building.
- Provide new lighting controls that meet the requirements of the Wisconsin Energy Code and the DFD Master Specifications and Design Guidelines.
- Include new emergency lighting and exit lighting to meet the requirements of the IBC.
- Lighting is to meet the requirements of the DFD Sustainability Guidelines for Capitol Projects V3-December 2021.

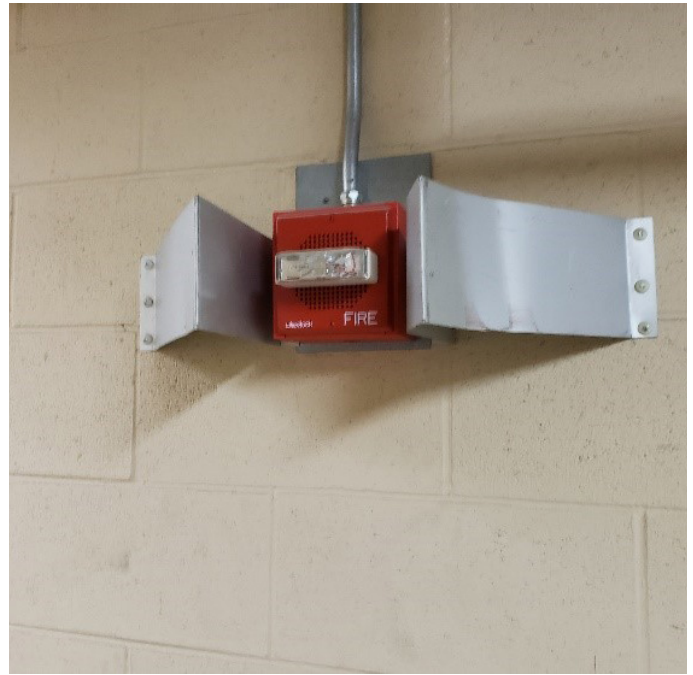
Audible Visual Fire Alarm Device

The fire alarm system is a Notifier Addressable system with Voice capability and appears to be designed for a high rise building with fireman's phones. System was installed in 1999 and the fire alarm control panel was upgraded in 2019. Facilities has indicated that fire alarm components have been piecemeal replaced and has a significant amount of old and original devices. Fire alarm system is nearing end of life and should be completely replaced.

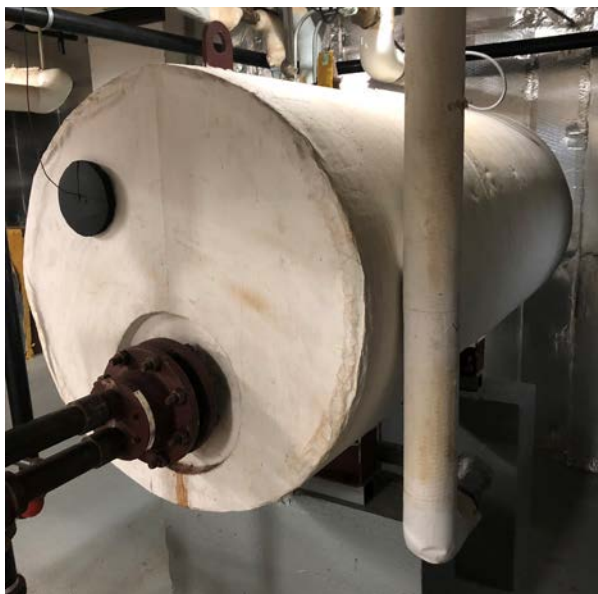
Domestic Water Heater

A shell and tube heat exchanger utilizes the building steam supply to heat the domestic hot water. It is quite old and is likely exceeding it's expected life cycle. Although operational, it may not be running efficiently. Depending on the maintenance schedule, it could be fouled and corroded within.

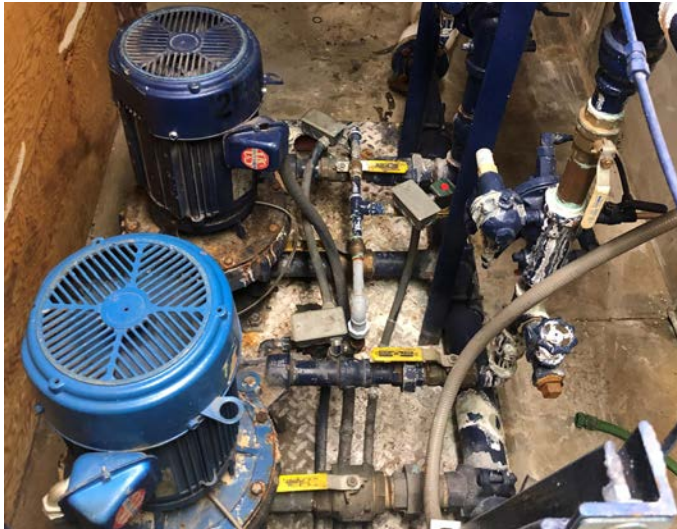
Domestic Cold Water Pumps

The domestic cold water and hot water supplies are separately boosted for the building needs. The cold water duplex booster pump is located in a basement mechanical space. It provides boosted cold water pressure for the entire building. As indicated by building maintenance staff, it is a manual changeover system that requires near constant maintenance and repair to keep it running. The simplex domestic hot water booster pump is in a janitor's closet on a tower floor. The pump serves to boost the city water pressure to provide hot water to the upper floors of the building. The pump is in good working condition.

The domestic cold water booster pump skid requires constant maintenance to keep it up and running. The domestic hot water booster pump is in good working condition but is in an obscure location in the building. Both the domestic cold and hot water booster pumps should be replaced with new duplex pumping skids. During a new design, the plumbing engineer should evaluate what piping strategy is appropriate for the boosted systems and what portions of the building supply should be boosted above city water pressure. The building likely requires two pressure zones. One would be on city water pressure and the other would be boosted as necessary for the upper floors. The engineer should consider using separate water heaters and softeners for each zone as well.

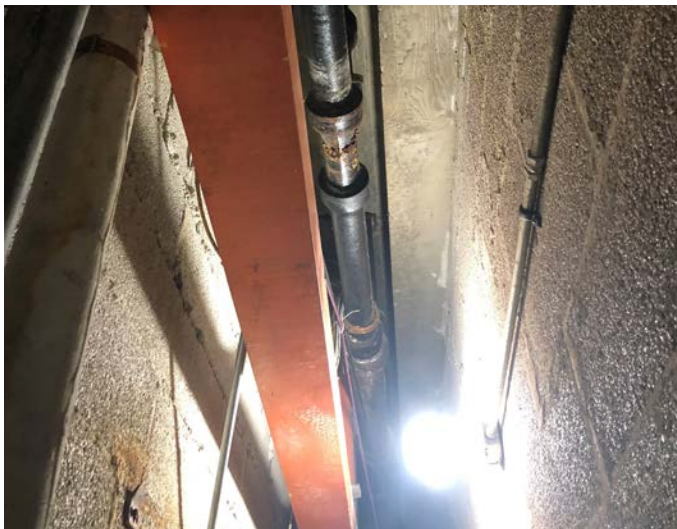
The sanitary waste/vent, storm water, and domestic water piping infrastructure is original to the building. Aside from small repairs done throughout the life of the building, the waste, vent, and storm water piping is all hub & spigot cast iron. The domestic water is a mixture of threaded galvanized and soldered copper. The waste & storm water piping is cracking, corroding, and leaking in many locations. The domestic water piping is leaking in certain locations. Building staff has indicated many valves are inoperable. Rust is present in the building water supply. The source is likely the building domestic water piping.

Condition of cast iron piping (note: this vertical plumbing chase will need to be infilled at each floor)

The piping infrastructure is original to the building and well past its life expectancy. It is failing in many locations and rust is present in the water supply. Due to these extensive issues a full replacement of all piping systems is recommended. This includes a replacement of all below grade piping as well.

Currently, the plumbing utility spaces serving the main restrooms in the building are full shafts. These spaces house the waste/vent piping, domestic water piping, and some ductwork. A review of the fire rating requirements for these spaces is recommended. A renovation may require the addition of floors to these shafts. Floors may also be required to mount carriers to support the weight of wall-hung toilets.

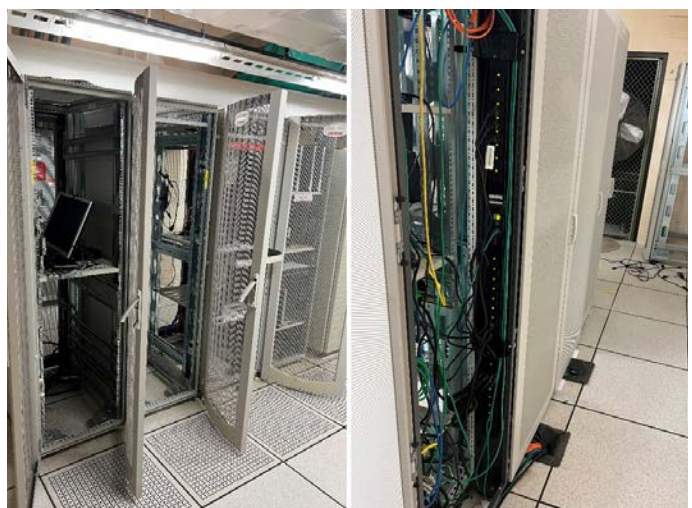
Existing equipment cabinets (Computer Room B331)

- Backbone and horizontal cabling recommendations are detailed on the following pages.
- Existing spaces including Router Room B333U, Computer Room B331, Raised Floor Storage B332, Computer Room B218 and Computer Room B224 are currently not in use and are not anticipated to be re-used for Telecommunications purposes. These rooms may be reallocated to new programmatic functions.

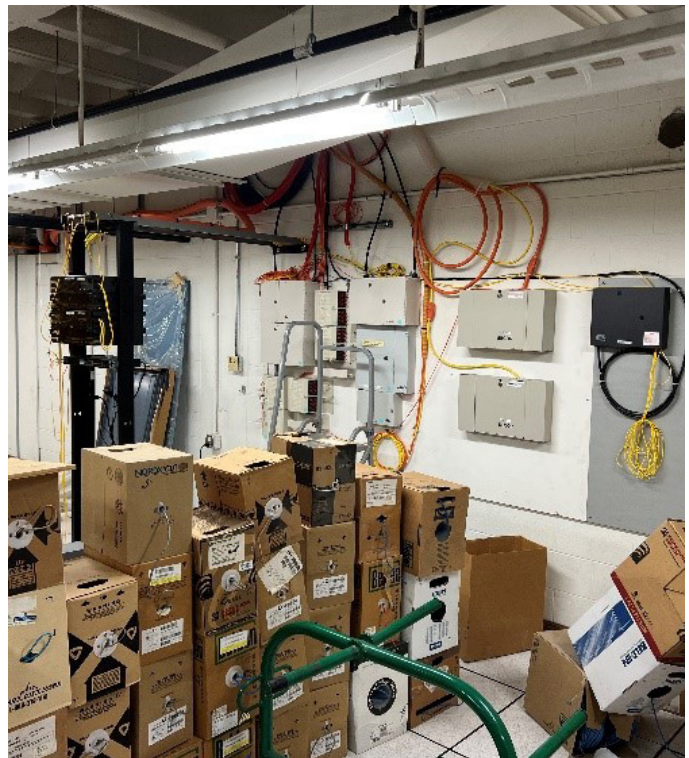
- The Capital Ring fiber optic cabling is terminated in wall and equipment rack mounted fiber cabinets located in Raised Floor Storage B332.
- Every fiber strand of the 96-strand single mode fiber optic cable in both directions (inbound and outbound) is terminated within 1 West Wilson (and within each building served by the fiber optic ring). Although not within the scope of the 1 West Wilson renovation project, it is the intention of DET to modify the Capital Ring to reduce the number of fiber optic terminations within each building served by the ring by only terminating a select number of fiber optic strands in each building in lieu of every single strand being terminated in each building with the ring.

Wall Mounted Terminations (Raised Floor Storage B332)

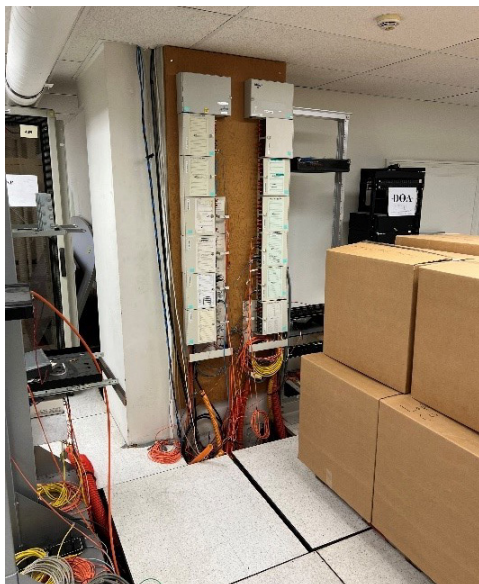
- Additional DET intra and inter-building fiber optic cabling is terminated in Computer Room B218 and B224 on Level B2 within wall mounted fiber optic cabinets. The destination of the DET inter-building fiber optic cabling appear to include (but is not limited to) 1 West Main, 1 East Main, and 101 West Wilson. These connections do not appear to be currently in use.

Inter-building Fiber Optic Cabling Terminations (Computer Room B218)

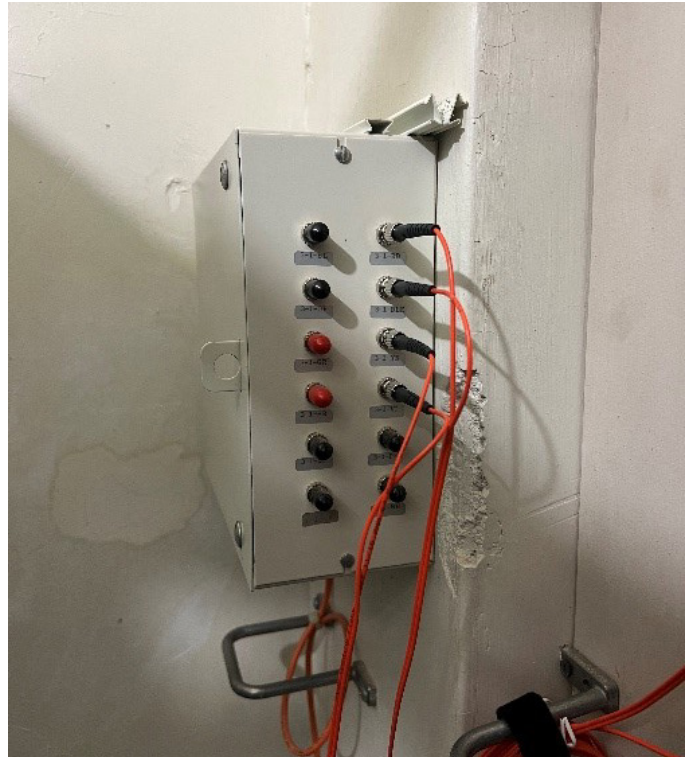
- The existing premise backbone fiber optic cabling system consists of 62.5 μm multi-mode cabling which is approaching end of life and has no industry roadmap for continued use. Each Telecommunication Room containing network connectivity is served by a 12-strand multi-mode cable terminated on ST connector.
- The fiber optic termination cabinets are typically wall mounted in the Telecommunication Rooms.
- Refer to the schematic drawing on the following page for backbone fiber optic cabling details.

Typical Telecommunication Room Wall Mounted Fiber Termination Cabinet

- All existing premise backbone cabling will be removed and replaced with new single mode fiber optic cabling to support an intra-building Passive Optical Network serving network switches. The fiber optic backbone cabling surveyed to ensure that there are no active connections on the cables prior to removal. Temporary cabling may be necessary to accommodate active circuits depending on the phasing of the renovation work.
