DOA # 21I2J / HGA #1190-035-00

1 WEST WILSON STREET BUILDING ASSESSMENT AND RECOMMENDATIONS STUDY

FINAL REPORT - MAY 10, 2022

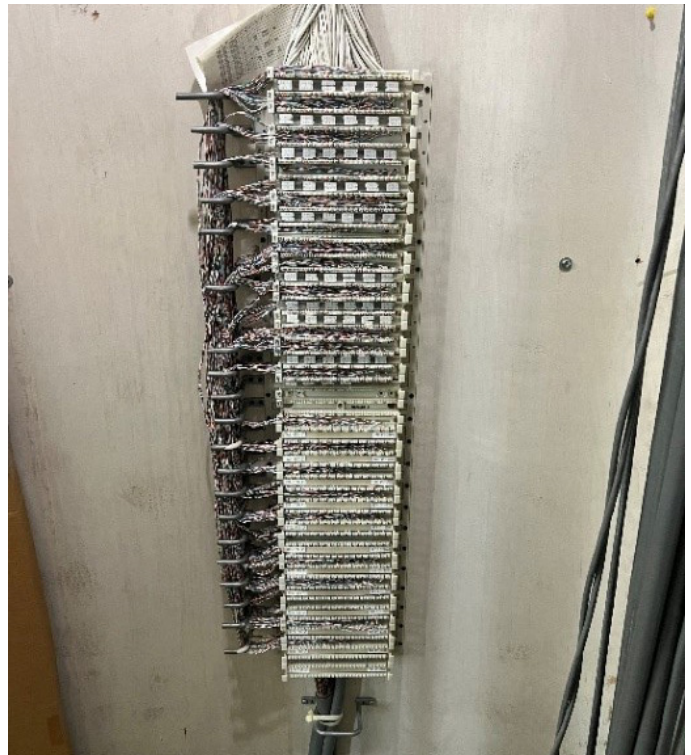
- The existing premise backbone copper cabling system consists of Category 3 cabling. The backbone copper cabling originates in Telephone Equipment B349Z and is terminated on 110 punch blocks mounted on the wall and floor mounted frames.
- Backbone copper cabling is terminated on wall mounted 110 punch blocks located in each Telecommunication Room (refer to the Telecommunication). Preliminary observations indicate that each of the 4-pairs in the horizontal cabling is cross-connected to the backbone copper cabling system. This is to be verified during the design process to validate new backbone copper cable sizes.
- Refer to the schematic drawing on the following page for backbone copper cabling details.

Category 3 Termination located in Telecommunication Room 272Z

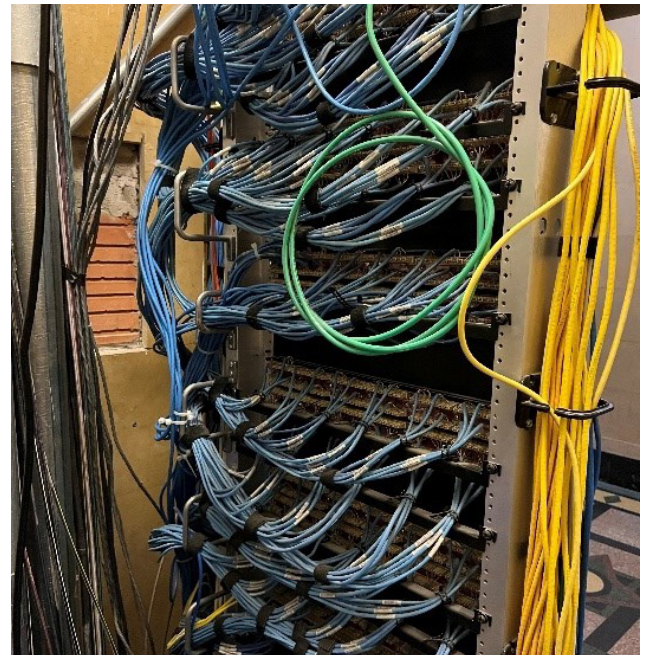
- Horizontal Data voice cabling consists of Category 5e cable terminated on modular jacks in equipment rack mounted patch panels located in alternating Telecommunication Room (Refer to the Telecommunication Room section above for details).
- Category 5e cabling is routed to workstation outlet on the floor and terminating on modular jacks in wall outlet faceplates.
- Patch panels outlets are patched to Agency provided network switches.

Category 5e horizontal cabling located in Telecommunication Room 154Z

- All of the Category 3 and Category 5e horizontal cabling will be removed from the building.
- The new copper horizontal cable system will consist of Category 6A cabling terminated in the new Telecommunication Rooms on each floor serving voice and data outlet located on each floor. The use of Category 6A is above and beyond current DFD guidelines. However, based on long-range planning, the nature of occupant (DHS) work and difficulty in future upgrades cabling in this building, installation of Category 6A cabling is recommended.
- New outlets shall be located per the programmatic requirements within each area of the building meeting DFD and Agency needs.
- Because the ceilings are being replaced, existing wireless access points shall be removed, stored and reinstalled. Each wireless access point location shall receive two Category 6A cables.

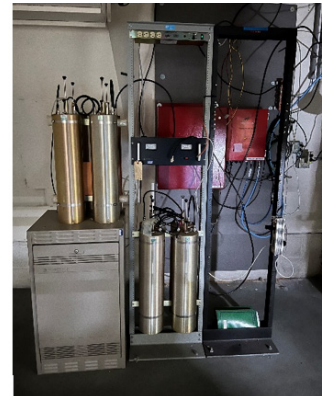
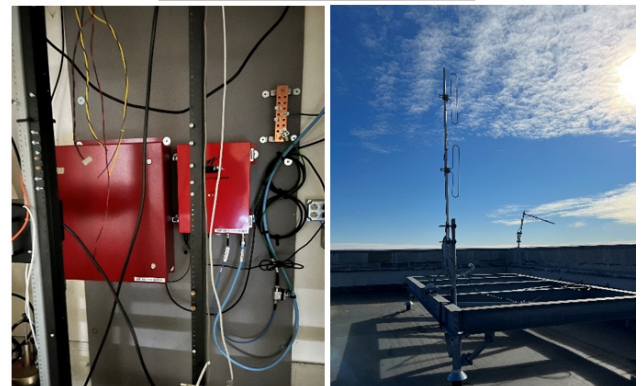
- Additional radio systems are located within 1 West Wilson, which may include State Police radio repeaters. These radio systems primarily reside in the Penthouse with antennas located on the roof.
- These systems may not currently be operational.

Existing Penthouse Radio Equipment and Roof Mounted Antennas

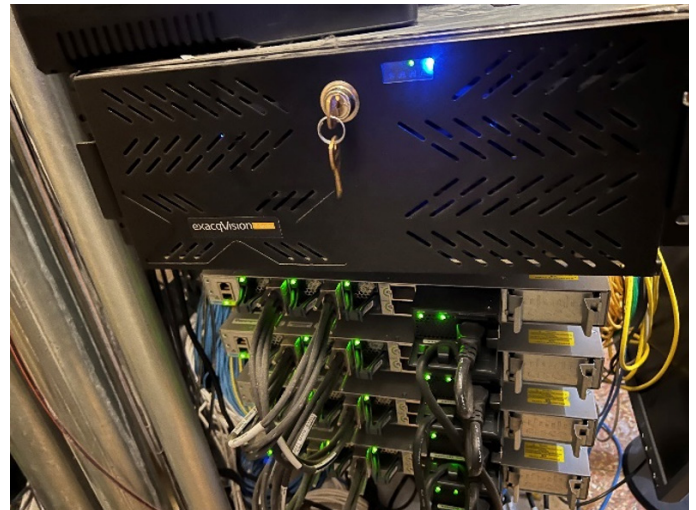
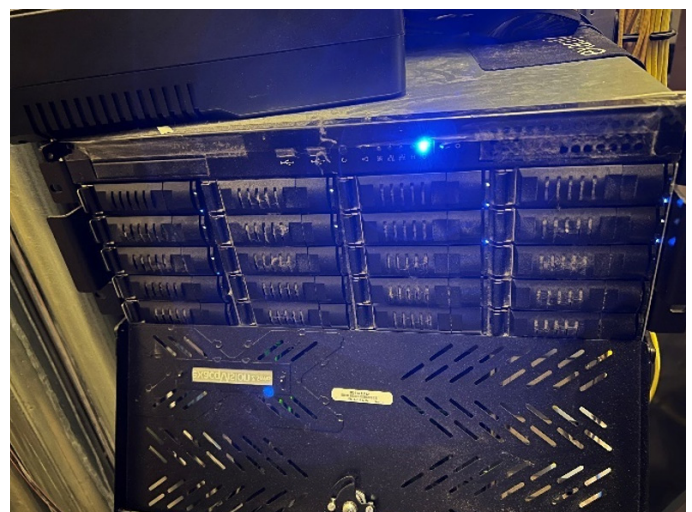
- The existing surveillance system consists of Exacq Vision Video Management System (VMS) with video being archived on a local network video recorder which is located in Telecommunication Room 154Z.
- The surveillance system is federated via a wide area network connection to a Capital Police Department Video Management System.
- The existing cameras are IP based and connect to the VMS via the facility network via owner network switches.
- Existing cameras currently survey the building exterior at the loading dock, the east face of the building, and the Level B4 exit to the railroad tracks. Existing cameras currently survey the building interior at the loading dock, the west exit located on Level B1, the two primary rear exits, and the Level 1 main hallway.
- Cameras currently consist of Axis cameras.
- The age of the surveillance system is unknown at the time of this assessment.

The existing Exacq Vision network video recorder located in Telecommunication Room 154Z

- The existing Exacq Vision network video recorder currently located in Telecommunication Room 154Z. This surveillance appliance will be relocated to Telephone Equipment Room B349Z.
- Because the ceilings are being replaced, existing cameras shall be removed, stored and reinstalled in new ceilings. Each camera location shall receive one Category 6A F/UTP cable.
- New camera locations shall be added to the building per the requirements of the new program as coordinated with DFD, DFTS and Agency representatives.
- The existing surveillance system operation and camera connectivity shall be evaluated in relation to the project phasing and coordinated with DFD personnel to limit system interruption and down times.
