## State Archive Preservation Facility Frequently Asked Questions

Last Updated: 3/17/17

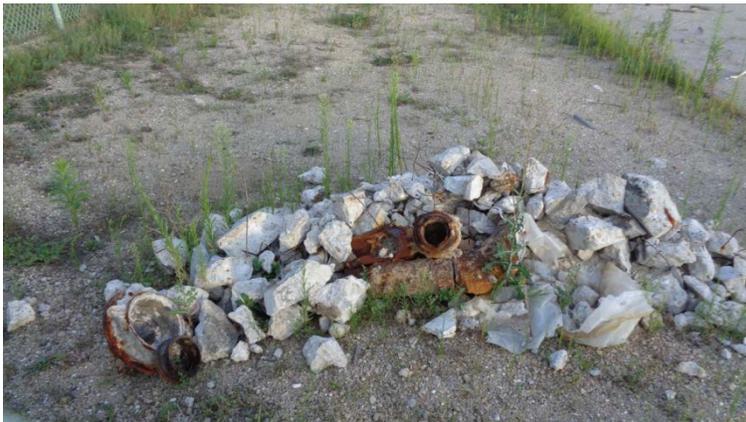
30. Concerns regarding the planned disposition of the rubble in reference to the photo taken at the site below.

The concrete, plastic, and rusty pipe in the referenced picture is located in an area which had no detectable concentrations of PCBs in soil from the Phase II ESA sampling event. The material indicates no observable staining other than from contact with the exterior of the rusted pipe embedded in the concrete. The material will be disposed along with other demolition debris from the project at an appropriate offsite facility.
